Dealer Product Campaign Bulletin

NUMBER: 77-C-13

SUBJECT: ONAN GENERATOR POSSIBLE 110V AC CONDUIT INTERFERENCE WITH POSITIVE BATTERY STUD

MODELS: 1976-1977 MOTORHOMES EQUIPPED WITH RPO KNC
(Onan 6.0 KW Generator)

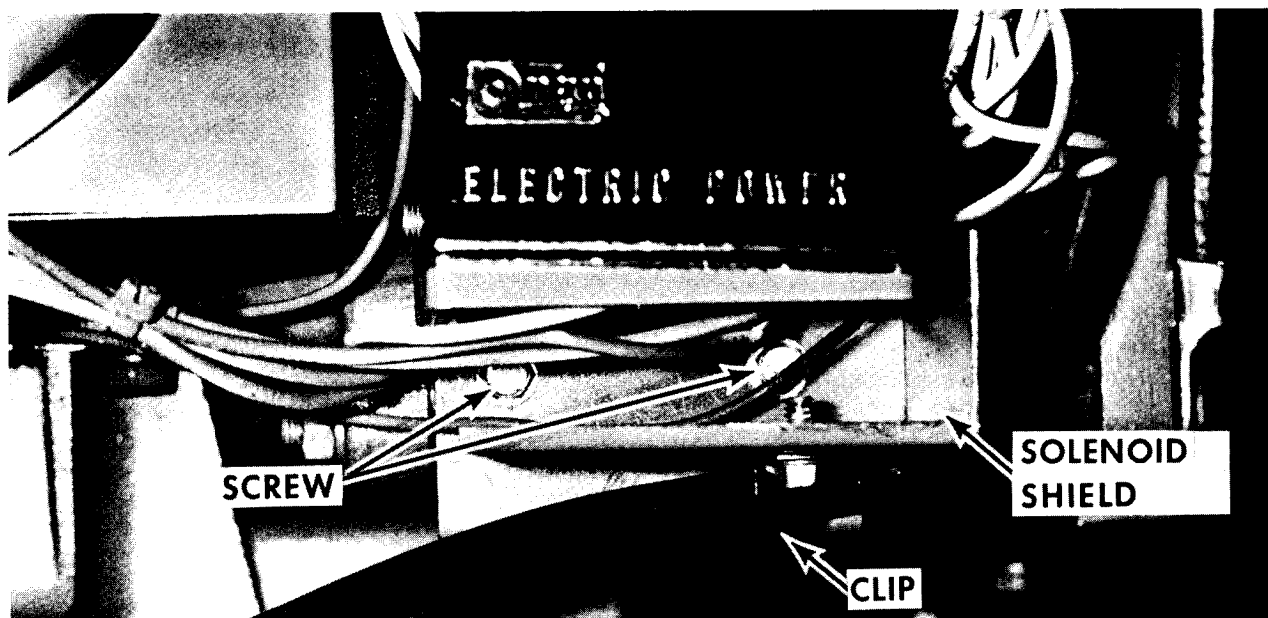
Figure 1

The 110 Volt AC conduit on these Onan generators may contact the positive battery terminal or starter solenoid post resulting in a short to ground of battery power. Also the 110 Volt AC conduit and cable insulation may wear through from contact with the negative battery terminal causing a short to ground of 110 Volt AC power. Such shorting will damage wiring and generator components and can result in a fire. A fire may result from shorting of the battery power to ground even if the Onan generator is not operating. The fire may burn the fuel supply hose to the generator unit resulting in a gasoline fed fire. Fires originating at the Onan generator could spread to the passenger compartment and cause burn injuries and asphyxiation of occupants.

3. Disconnect ground cable at living area battery.
4. Remove two screws located under the control board. (Refer to Figure 1).
5. Position solenoid shield as shown in Figure 2, and install retaining screws. The control panel ground wire must be properly secured at this time. Secure starter cable with clip as shown in Figure 1.
