MOTORHOME SERVICE BULLETINS INDEX

TRUCK & COACH DIVISION
GENERAL MOTORS CORPORATION
Pontiac, Michigan 48053

**INDEX
OF
GMC MOTORHOME SERVICE BULLETINS**

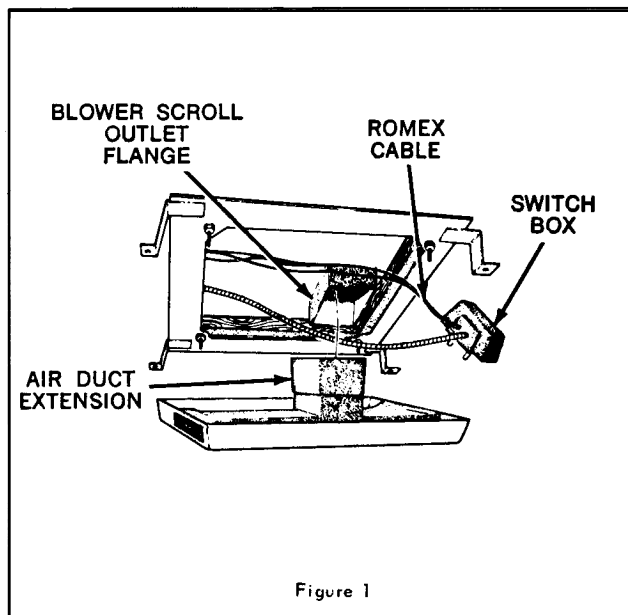
Another condition which can cause insufficient cooling of the roof top air conditioner is when the air duct extension is not properly fit into the blower scroll outlet flange (see figure 1). Make sure that the galvanized sheet metal duct has no gaps between it and the outlet flange. If a gap exists, this can cause cooled air to escape into the plenum chamber, prematurely shutting down the unit. Regular furnace duct tape may be wrapped around the flange and duct extension to correct this condition.

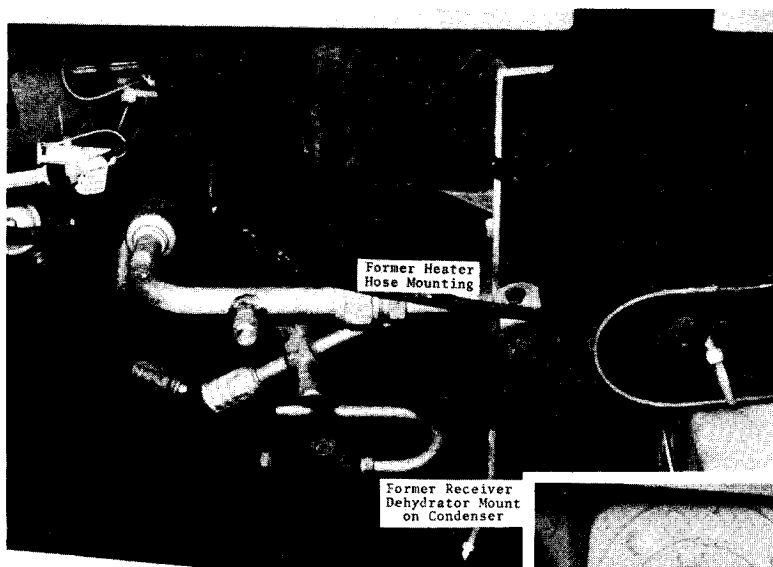
FIGURE 1 - FORMER INSTALLATION OF RECEIVER DEHYDRATOR

GMC Technical Service in cooperation with Engineering has recently released a new method of mounting the receiver dehydrator. The new mounting location, on the evaporator assembly housing, is designed to relieve stress on the condenser discharge tube and give a more stable mounting to the receiver dehydrator. (Figure 1 - Old Style Mounting) (Figure 2 - New Style Mounting)

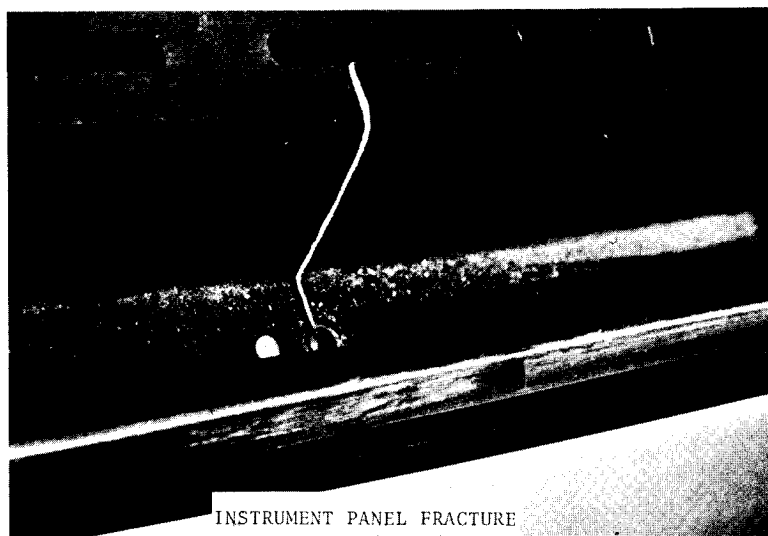
FIGURE 1

INSTRUMENT PANEL FRACTURE

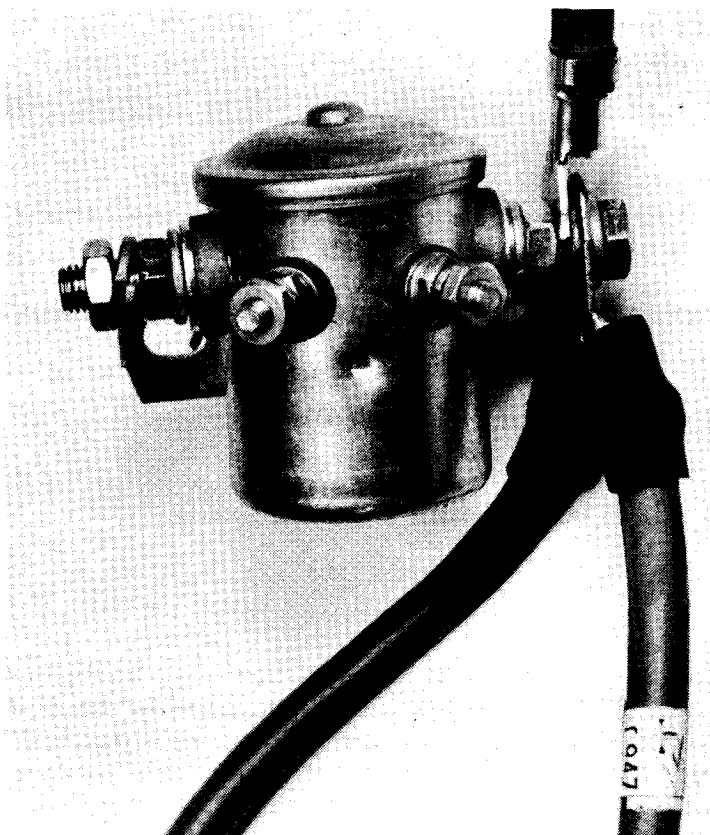
CORRECT METHOD OF TERMINATING CABLE ENDS

Proper method of installing these cables to the magnetic switch is to be certain that the flat side of the cable ends are installed towards the magnetic switch, being certain that the rubber insulator does not touch the switch itself. (See Photographs)

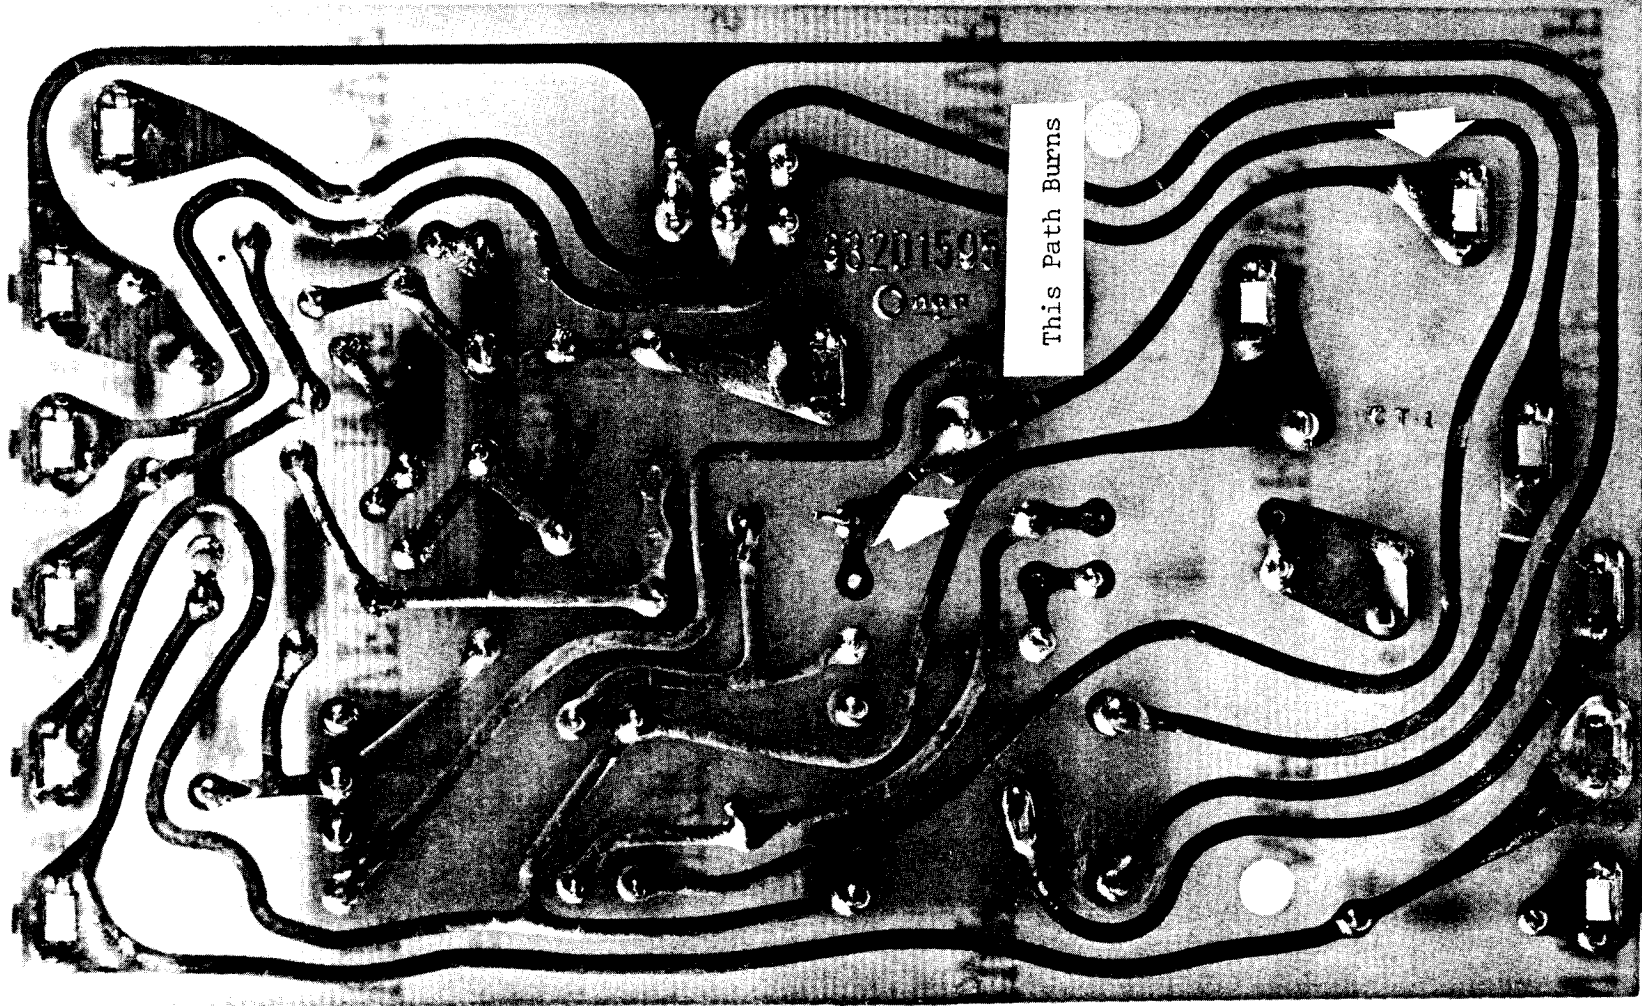
This Path Burns

It is recommended that when work is being done on the board, which does not include reading voltages, that the battery be disconnected. It would also be advisable when removing a fuse to use a standard plastic fuse puller and installer which is available at any auto parts store.
