The Beginning of a Classic...

The Manufacturing of the GMC Motorhome

Plant No. 3 Birthplace of the GMCMH

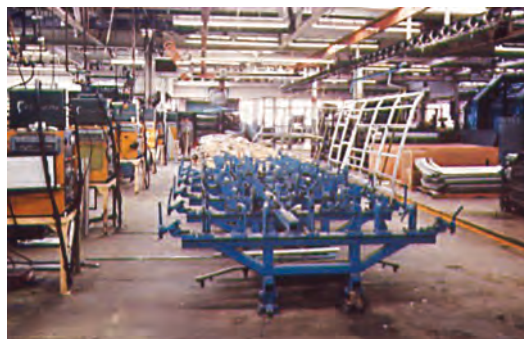
Top roof assembly fixture.

1. Roof and Side Panel Assembly

- Welding aluminum extrusions into rugged, truss-line structures
- Space-age adhesive used to “glue” exterior panels to side and top frames
- Adhesion, curing under controlled heat and pressure

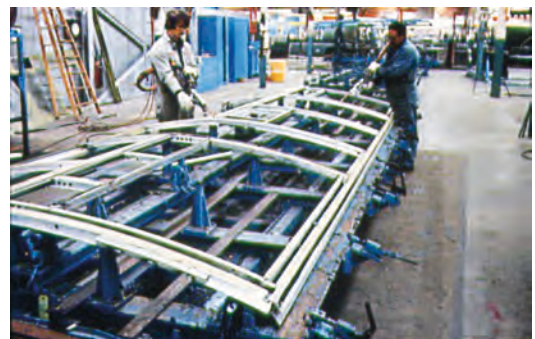
Body side frame assembly fixture.

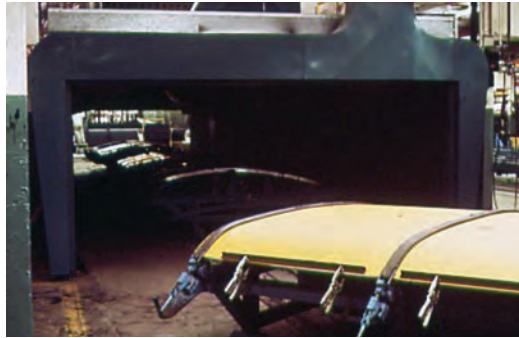
Top roof panel to frame bonding entering cure oven.

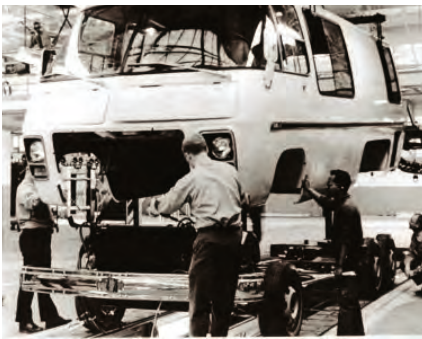
Body drop.

19. Body Mount

- Completed body from upper level lowered onto completed chassis
- Body-setting team takes over, stays with vehicle to the end
- Body indexed to frame, bolted in place
- All air and electrical lines hooked up

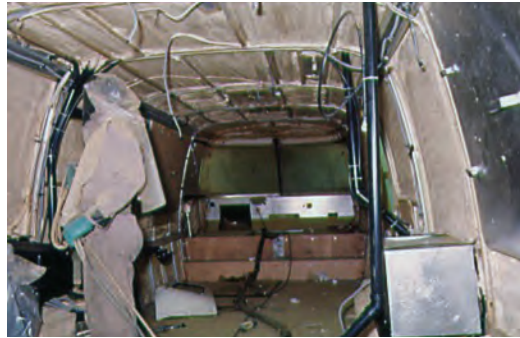
Spraying of foam insulation.

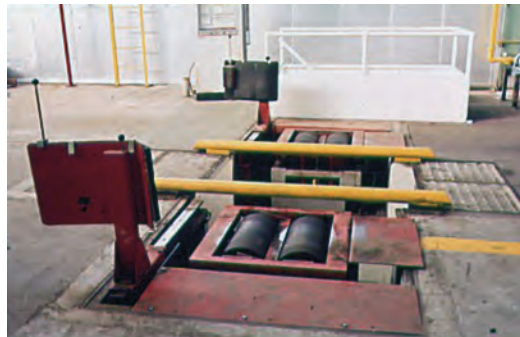
Check of motorhome engine/drive train.

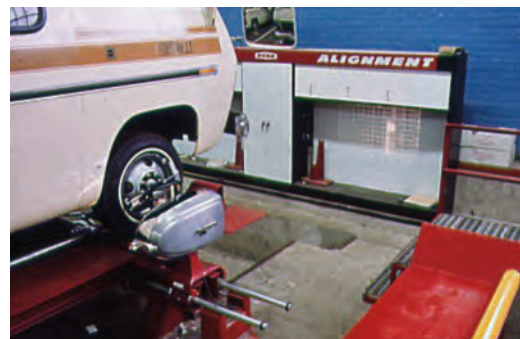
Bear Alignment station.

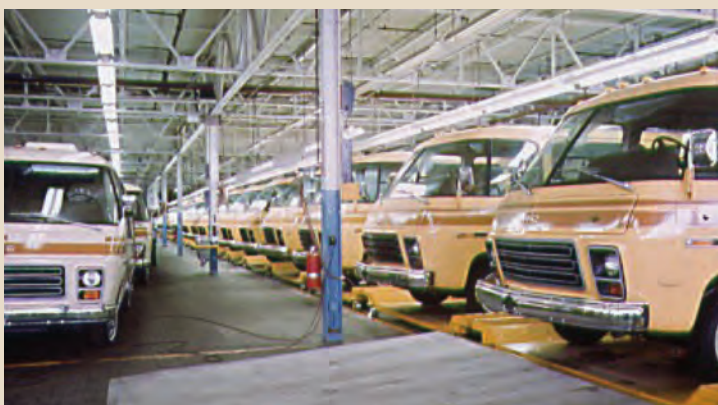
GMC Motorhomes conveyed sideways on dollies along assembly line.

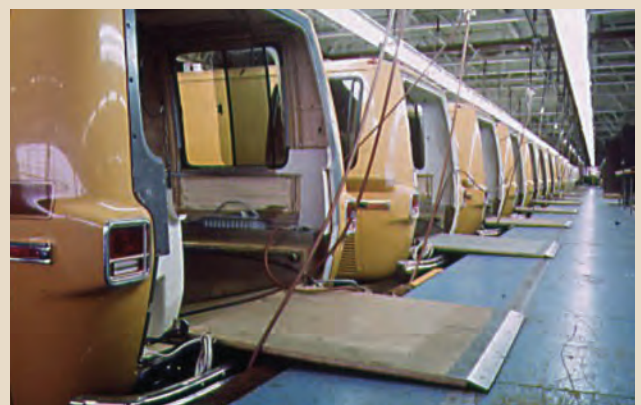
Upfitting of interior modules.
