MOTORHOME SERVICE BULLETINS INDEX

TRUCK & COACH DIVISION
GENERAL MOTORS CORPORATION
Pontiac, Michigan 48053

**INDEX
OF
GMC MOTORHOME SERVICE BULLETINS**

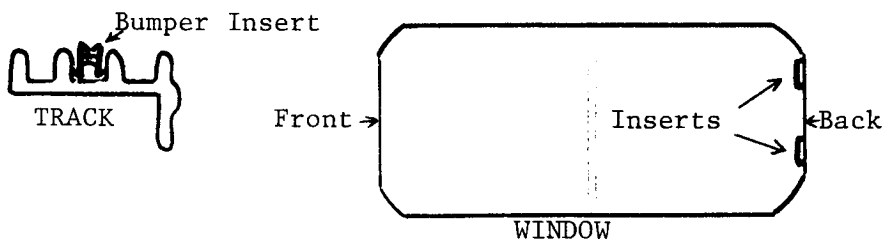
Broken stop may be lodged in back bottom corner - be sure to remove.

A bumper insert is now available for placement in the sliding side windows on 1976 and 1977 GMC Motorhomes and Transmodes to eliminate window rattles.

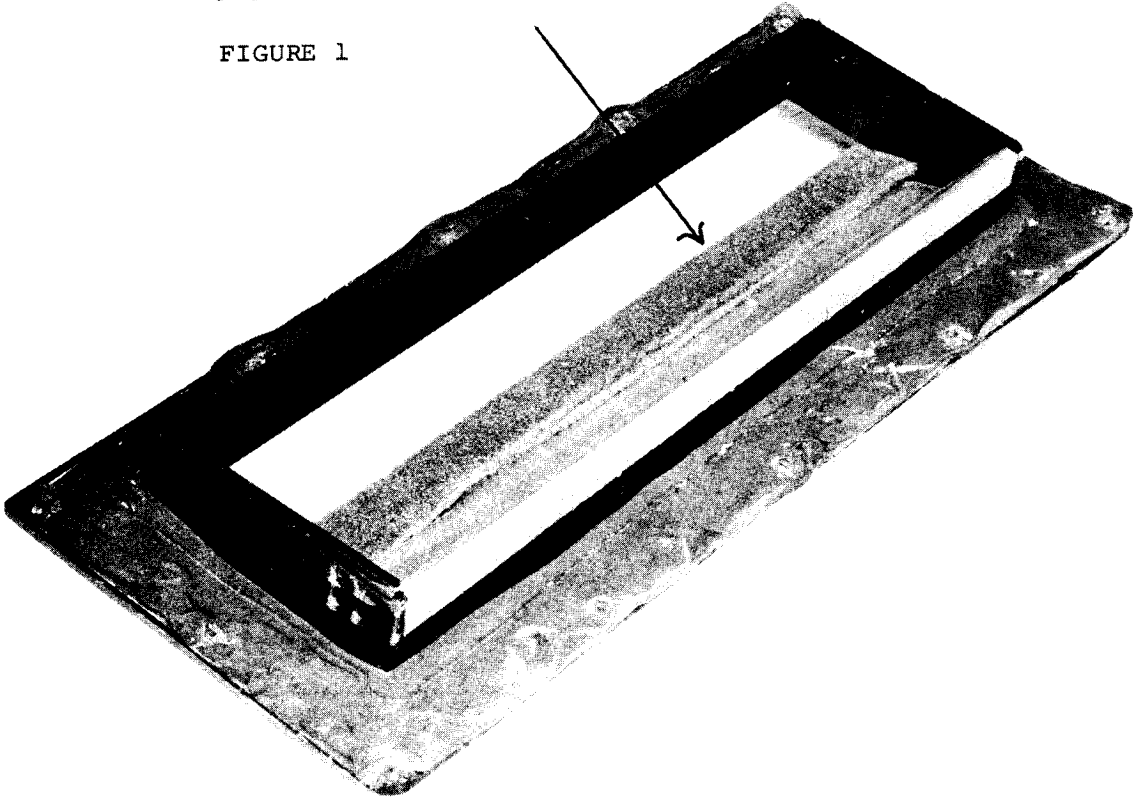
FIGURE 1

Rubber strip glued to flapper

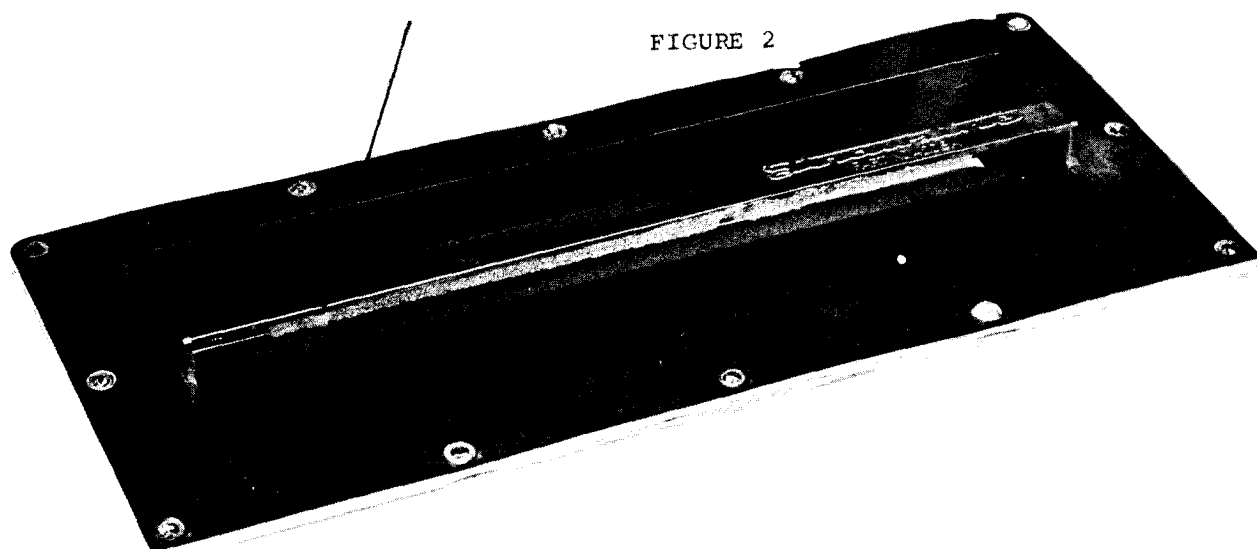
FIGURE 2

Thin rubber strip glued to housing

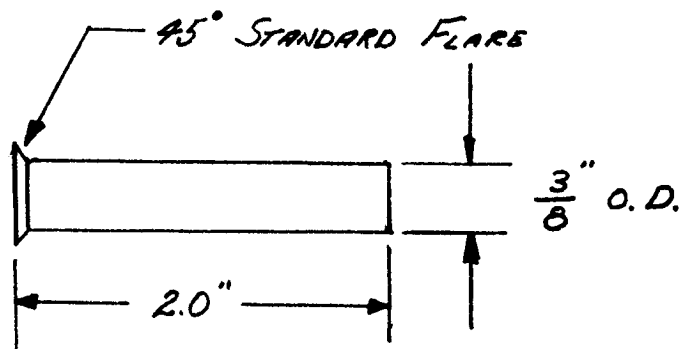
SUBJECT: Potable Water Tank Breakage & Leaking

Install a piece of $\frac{3}{8}$ " O.D. copper tubing approximately 2" long inside the tube.

In order to keep the tube from working its way inside the tank, a standard 45° flare should be put at the outlet end. This copper tube will help reinforce the plastic and prevent distortion. Part number of the tank is 706126.

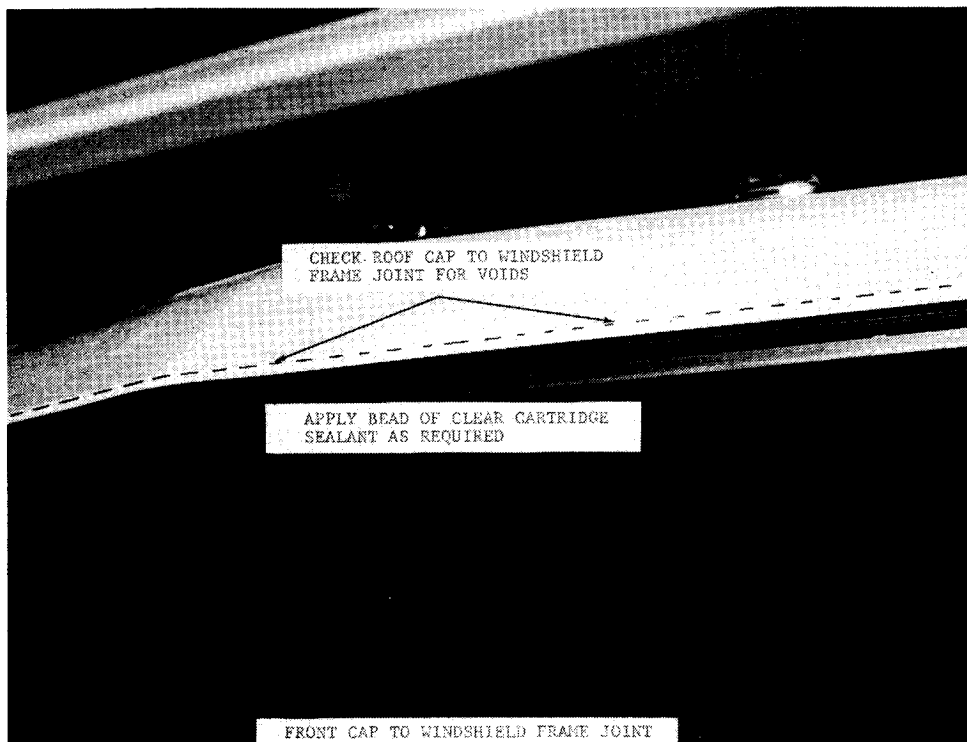
<u>Water Evidence @</u>	<u>Probable Entry @</u>	<u>Correction</u>
. Horn Button	. Front cap to windshield frame joint.	. Apply clear cartridge sealant to voids in joint as shown.
. Passenger or Driver's Lap		
. Inside Rear View Mirror Bracket

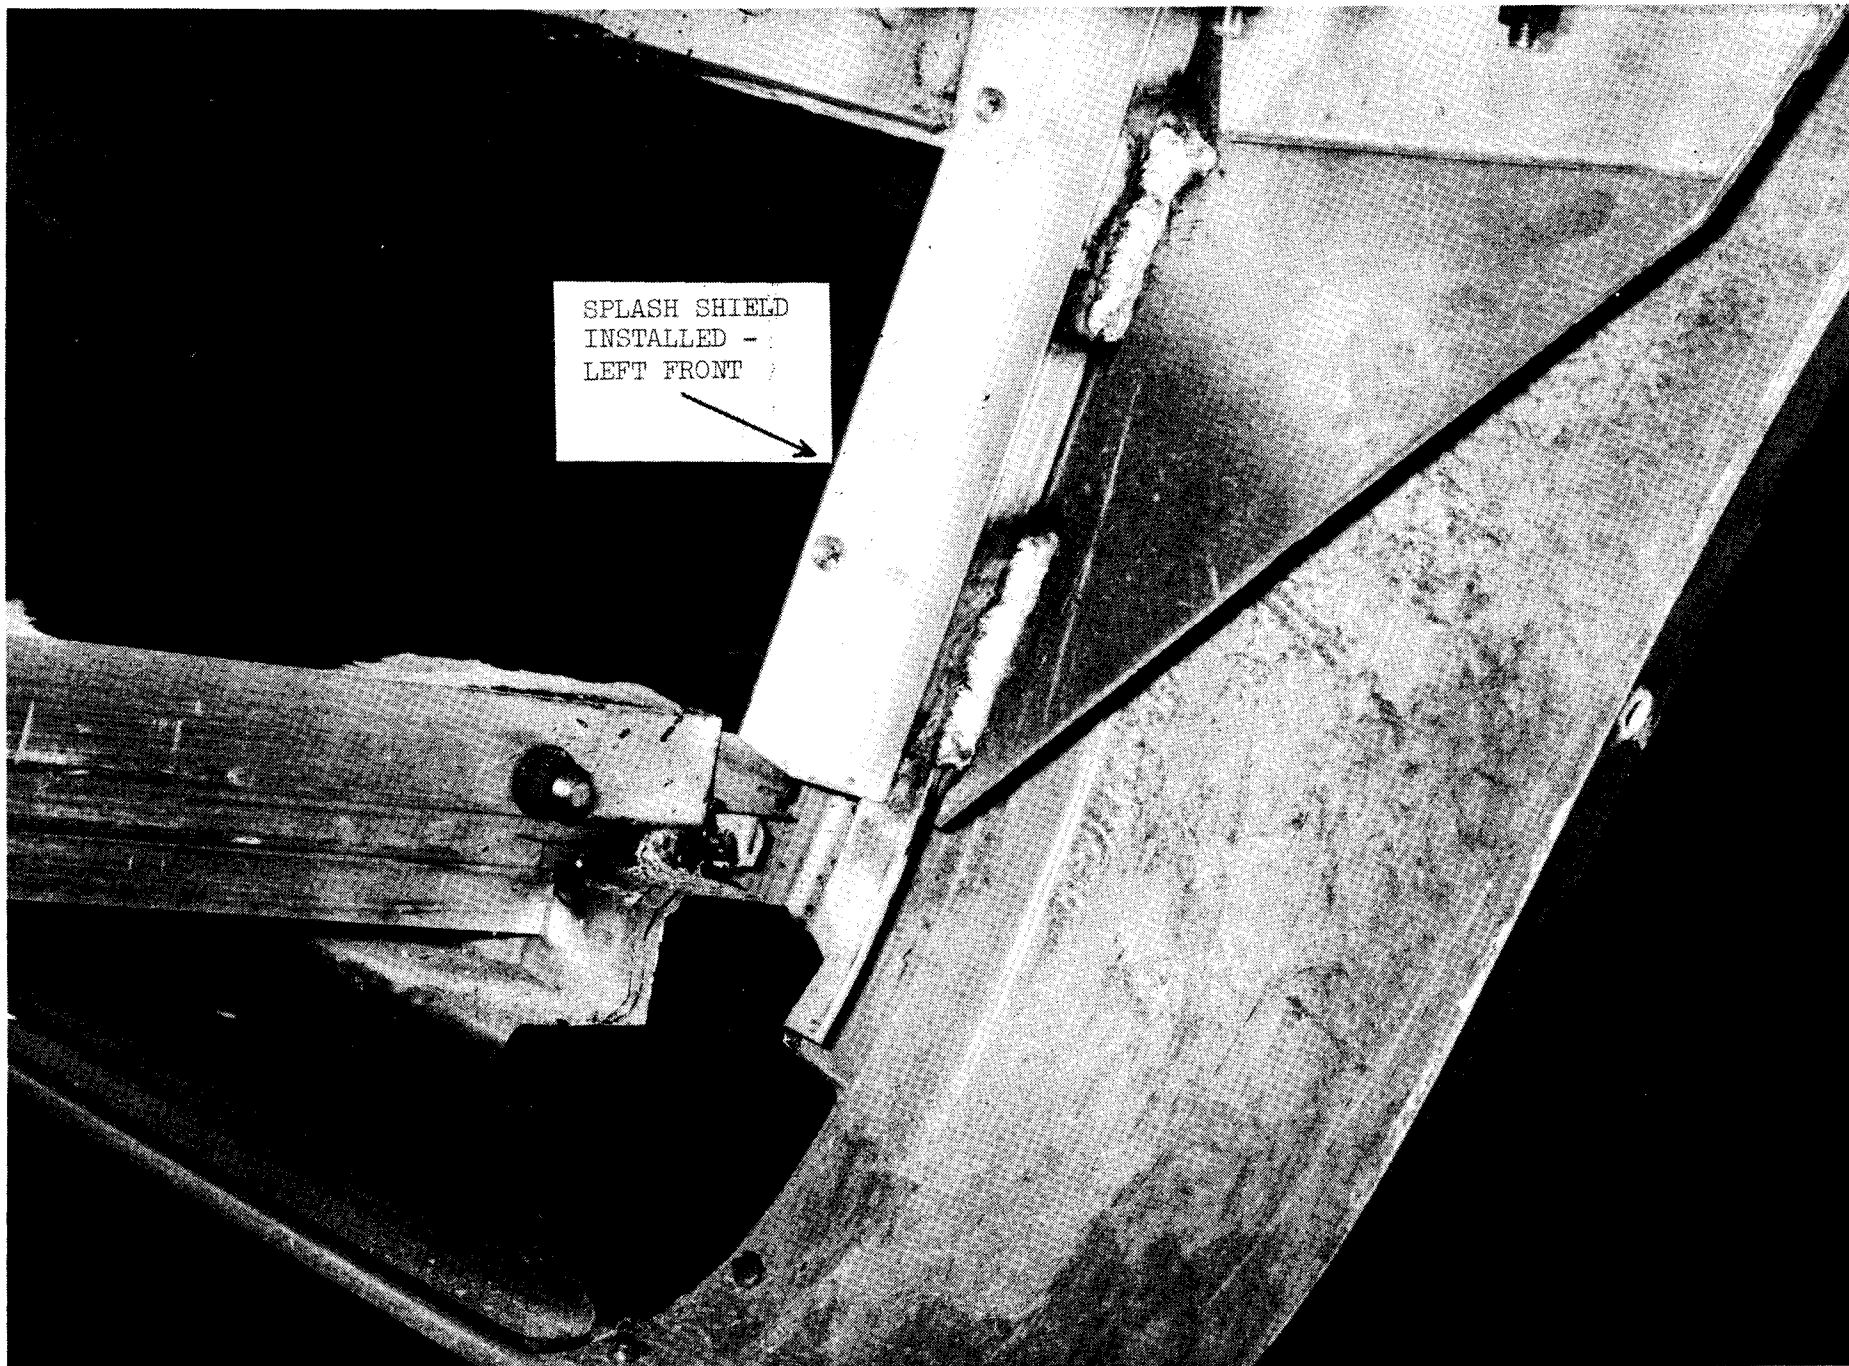
SPLASH SHIELD
INSTALLED -
LEFT FRONT

Early production 1975 model GMC Motor Homes and Transmodes serial number 5V100001 to 5V100367, may have been built without the lower step riser splash shield. Omission of the shield may result in a water leak at the base of the step.

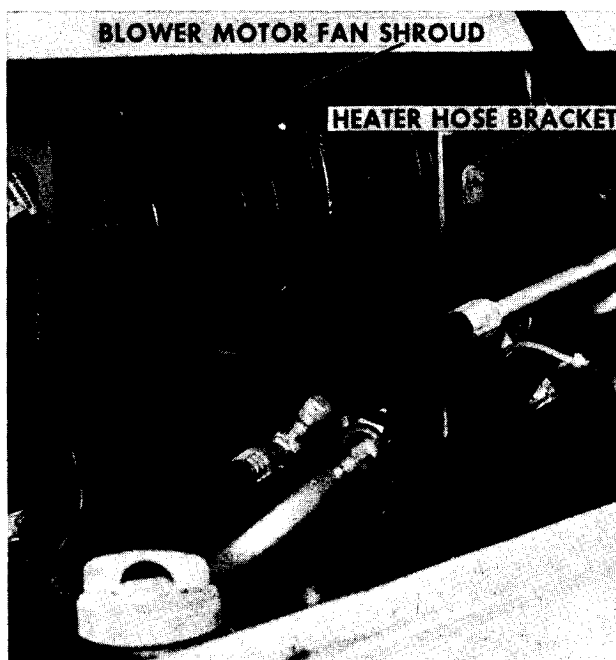
Figure No. 1

Some owners may experience leakage of cold air through the duct below the instrument panel in all heater modes due to the auxiliary temperature door not closing completely. The following is the procedure for the adjustment of the auxiliary temperature door.

1. Loosen heater hose bracket to allow freedom of movement of heater hoses. (Figure 1)
2. Disconnect hot wire from blower motor.
3. Remove two nuts holding blower motor fan shroud to evaporator housing. Wires from compressor discharge pressure switch may have to be removed to provide wrench clearance.
4. Lift out blower motor and fan housing making sure to lift upward to clear the air outlet passage.

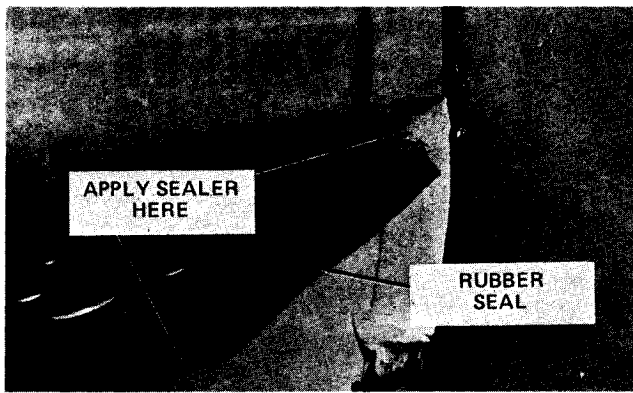
FIGURE 3

3. The rubber seal shown in Figure 3 should be checked for proper location and sealing. If the seal is inadequate, fill with putty type sealer.

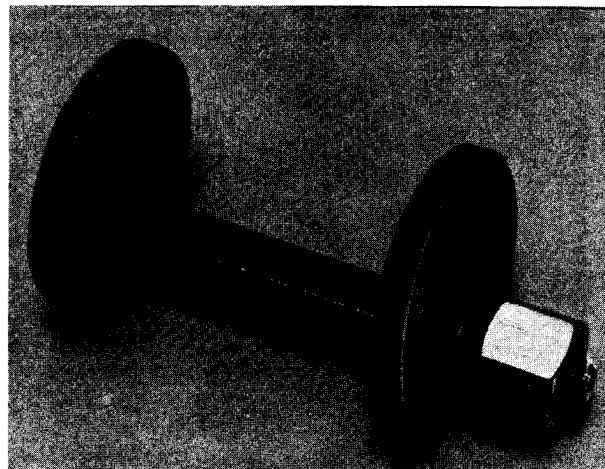
FIGURE 2

A free-spinning nut with a lock washer was used in production of the above models (Figure 2). This setup may continue to be used in service on these production built vehicles and the nut torque specification remains 80-110 lbs. ft. hand torqued.

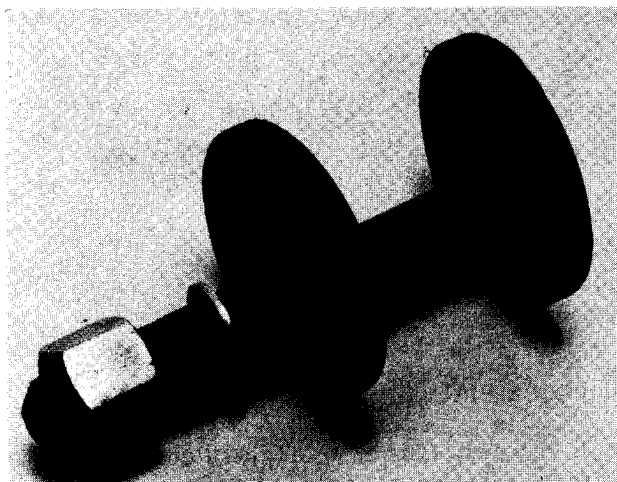
FIGURE 3

A free-spinning nut with a hardened steel flat washer is used on 1975 models (Figure 3). A new nut torque specification of 80-95 lbs. ft. hand torque must be used.

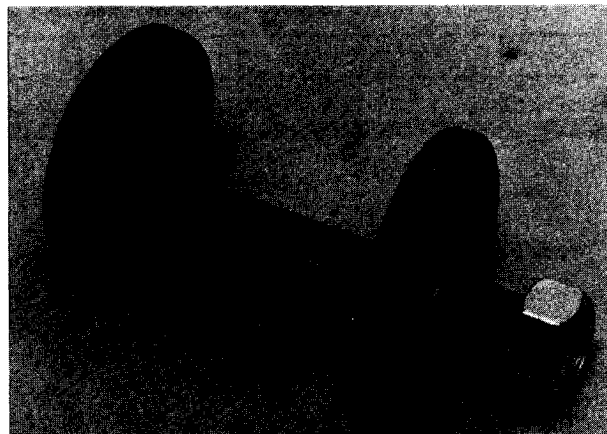
FIGURE 4

On some 1975 motor homes and transmodes a prevailing torque nut with a hardened steel washer was used (Figure 4). To facilitate front end adjustment it is necessary that **all** the bolts, nuts and washers be changed to: 395039 – bolt, 394382 – free-spinning nut, and 794360 – hardened washer, four (4) required per vehicle. Nut torque specification of 80-95 lbs. ft. hand torque must be used.

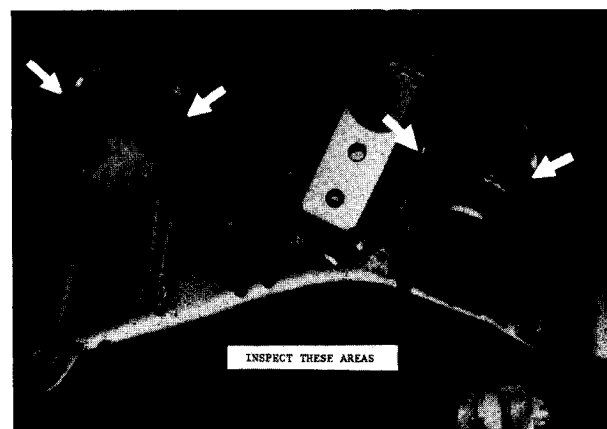
FIGURE 5

In all cases the outer surfaces of the upper control arm frame brackets in the mating area of the adjusting cams must be inspected for weld spatter (4 places) (Figure 5). If encountered, the surfaces (4 places) must be cleaned of all weld and weld spatter to provide for proper clamp load.

NOTE: Prior to final alignment, vehicle **must** be trimmed to proper ride height. After final alignment, torque cam nuts while holding bolt heads securely so that adjustment is not changed. Refer to Maintenance Manual for all additional information.

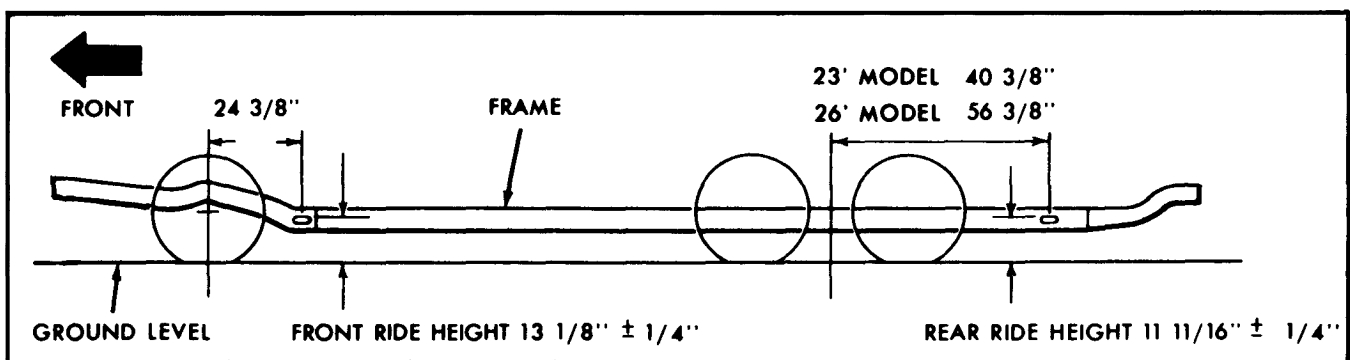
Figure No. 1— Ride Height Adjustment

1. Inflate tires to proper pressure -
 - . Steel belted bias ply tires - 60 psi.
 - . General Jumbo steel belted radial tires - 65 psi.
2. Check ride height for sag and unevenness. On a level surface, set ride height as shown in Figure #1.

<u>CONDITION</u>	<u>USE PART NUMBER</u>	<u>ANCHOR ARM ANGULARITY</u>
. Vehicle too high	413683	23°
. Vehicle too low	418352	25-1/2°
. Vehicle extremely low	416373	28°

If changing the anchor arm does not correct the ride height, inspect the lower control arm for galling, bulging or splitting, and inspect the control arm end of the torsion bar for wear. Replace as necessary.

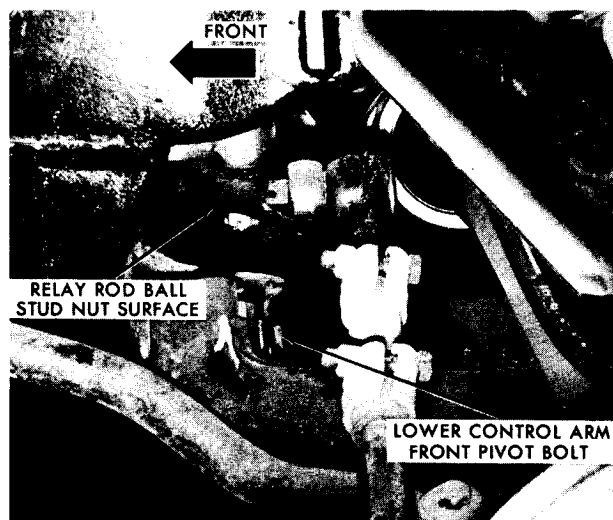
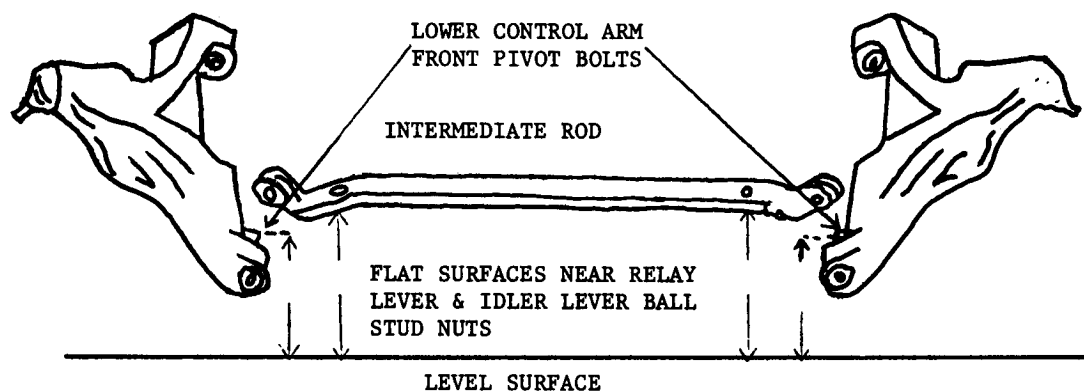
FIGURE #2

Inspect the intermediate rod for parallelism with the front axle to eliminate the possibility of front tires wearing unevenly. The parallelism can be measured and corrected as follows:

* IF ENTRY "G" IS .125" OR GREATER, ADD TWO HARDENED STEEL WASHERS UNDER THE IDLER LEVER PIVOT AS SHOWN IN FIGURE #3. OTHERWISE, THE INTERMEDIATE ROD PARALLELISM IS ACCEPTABLE.

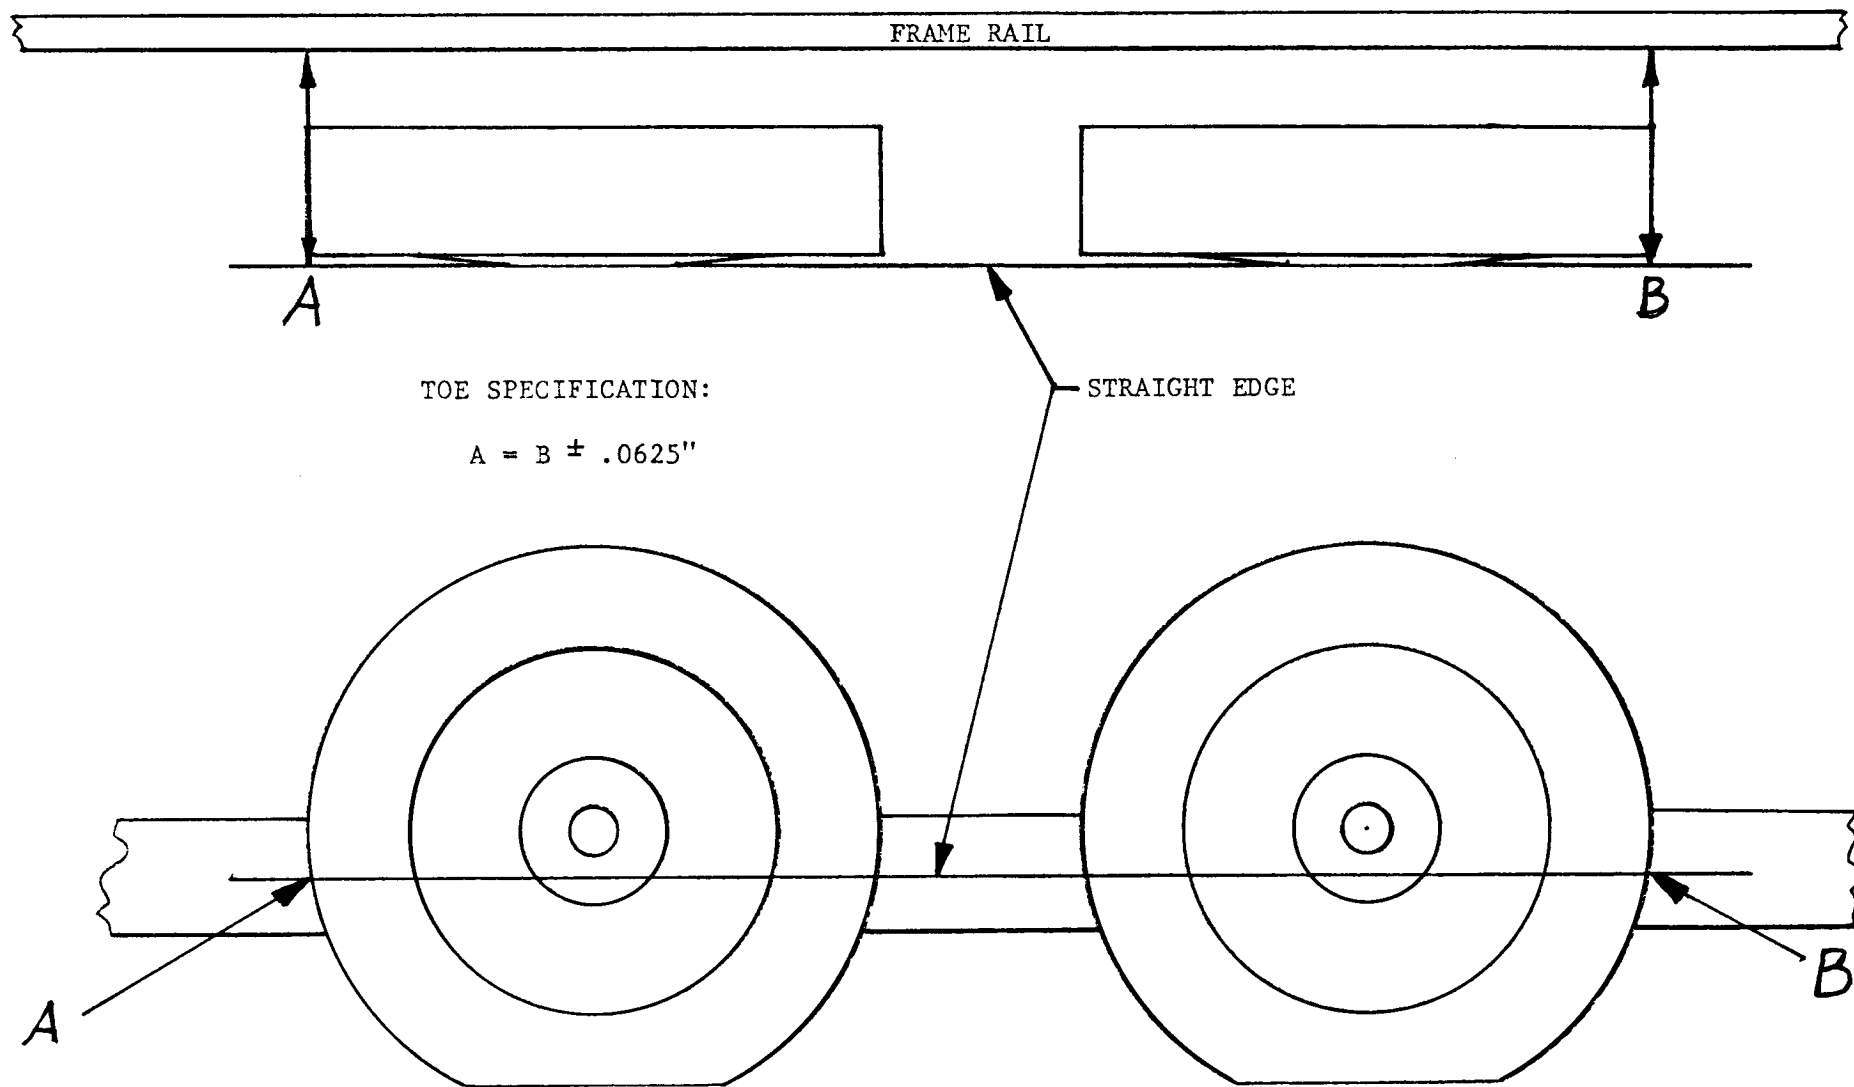
Figure 4

If one side of the Motorhome rear suspension appears to be the primary cause of excessive toe, use the following procedure for measuring toe on one side of the vehicle. This will assist you in determining which rear suspension component is defective or damaged.

- . Drive vehicle straight forward onto a level surface.
- . Remove wheel covers and outer dust cap.
- . Place straight edge across face of wheels as shown in Figure #4.
- . Measure distance from straight edge to frame at front tire and rear tire as shown. Toe should be $A = B$ plus or minus .0625".
- . Add toe shims as required. One toe shim changes $A = B$ by .125".

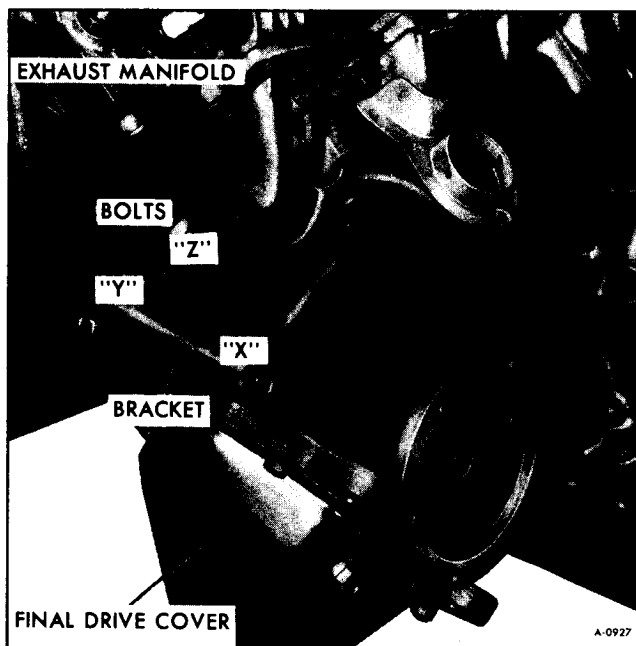
Alternator misalignment can occur on some 1977 Motorhomes equipped with a 403 cu. in. engine and a final drive to engine bracket (P/N #397476). Alternator misalignment may permit the drive belt to be thrown off the alternator pulley. When alternator drive belt problems are encountered on Motorhomes equipped with the 403 cu. in. engine and a final drive to engine bracket, the bracket should be removed.

The final drive bracket is removed by removing bolts X, Y and Z as shown in Figure #1 below. After the final drive bracket is removed, install bolt "X" and torque to 110 ft. lbs. Tighten and torque bolts "Y" and "Z" to 55 ft. lbs.

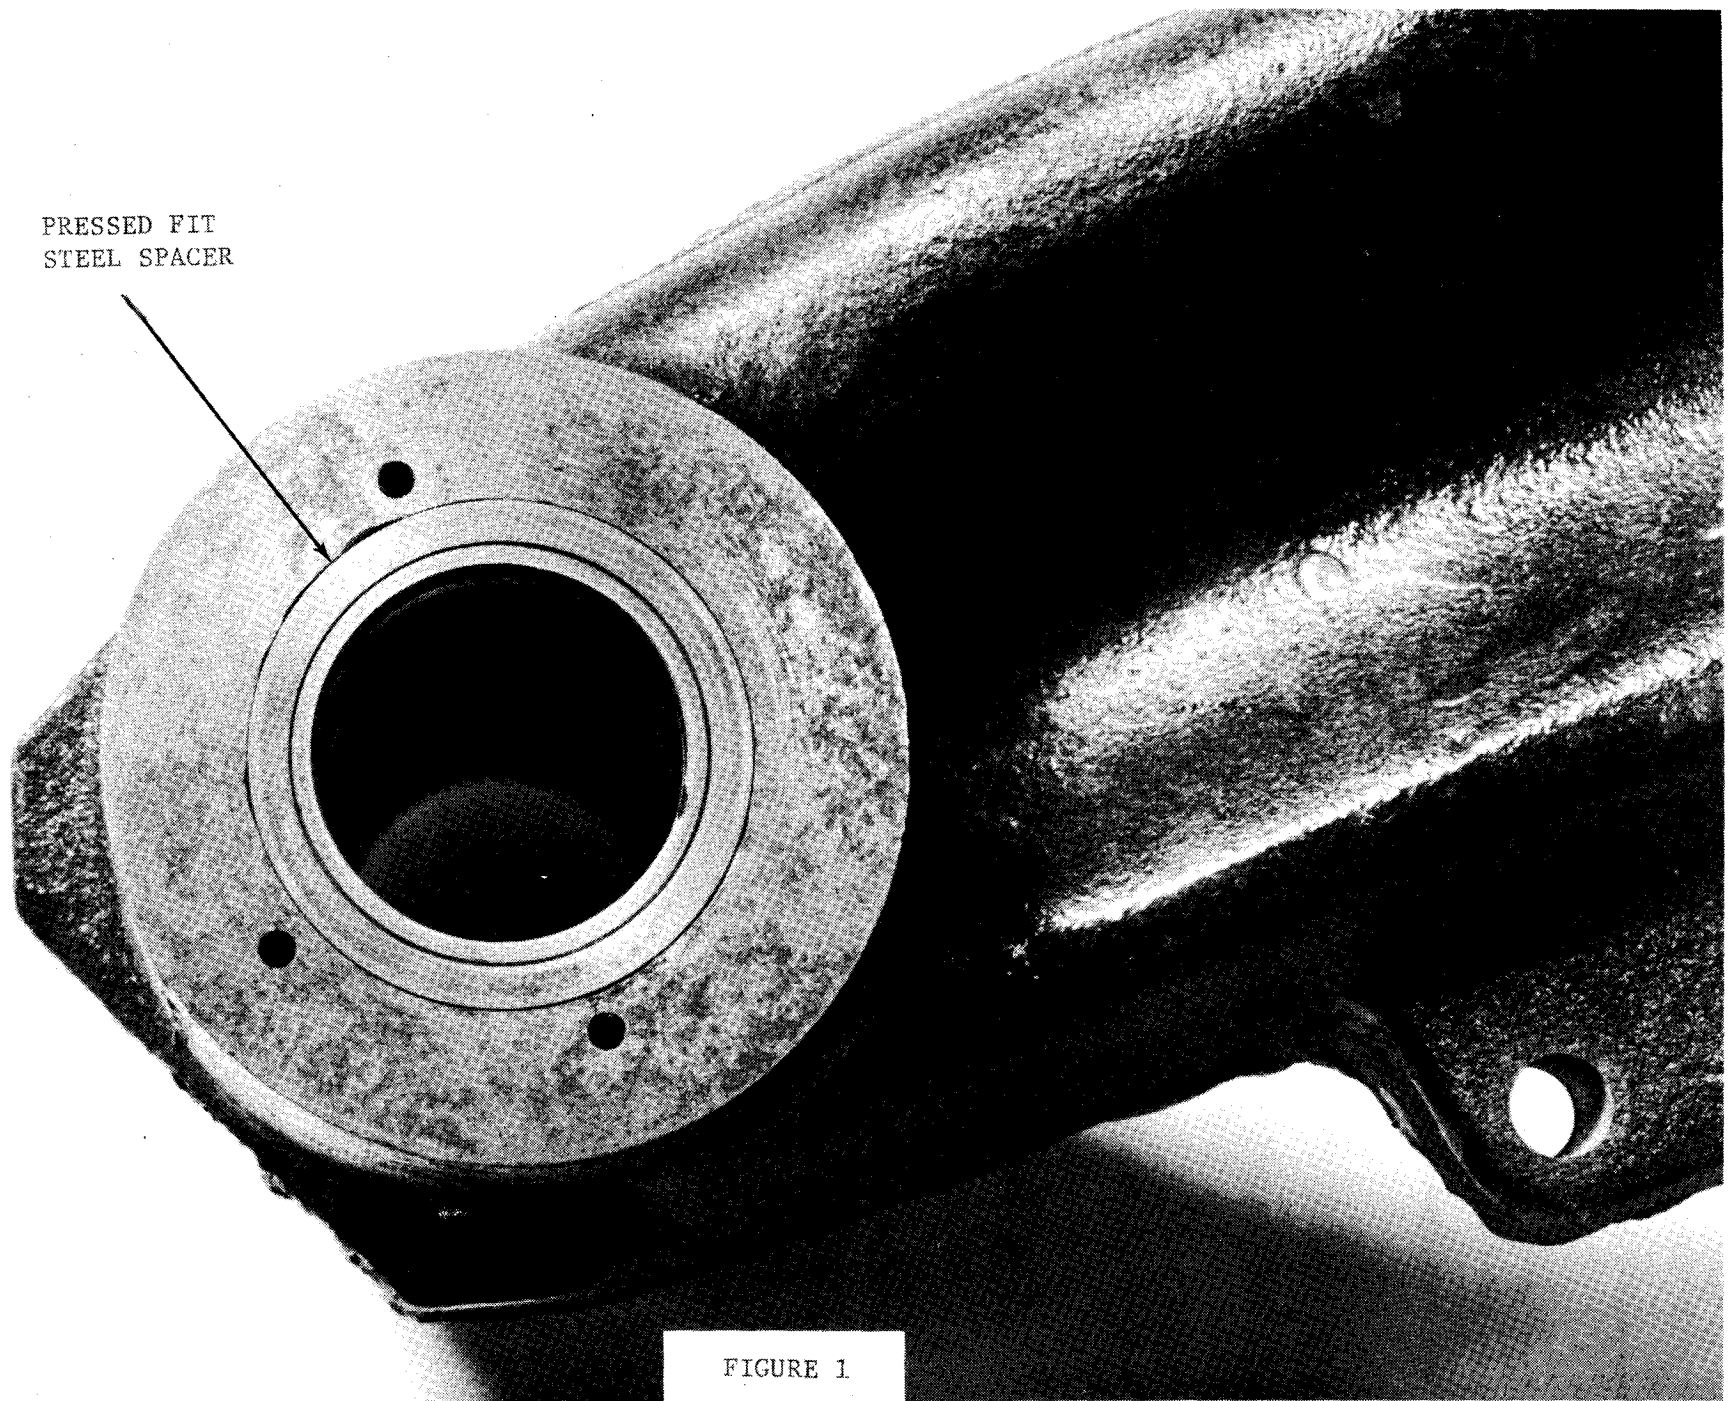
FIGURE 1

When it is necessary to replace a 706862 or 706863 control arm, both a new control arm and spacer kit must be ordered. If the rear suspension bushing and pivot pin replacement described in Dealer Service Technical Bulletin 75-TM-4 has not been made, it will be necessary to make the modification at this time.

1. Remove existing 1-1/2" dia. bushing from control arm, part numbers 721316 or 721317, if installed.
2. Press the 1-1/4" dia. spacer into the arm until the spacer is flush with the machined surface of the arm. (Figure 1)
3. Install the 1-1/4" dia. bushing inside the steel spacer using tool J-25369. (Refer to Bulletin 75-TM-4)
4. After both bushings are installed in the control arm, ream to size using reamer J-25281. (Refer to Bulletin 75-TM-4)

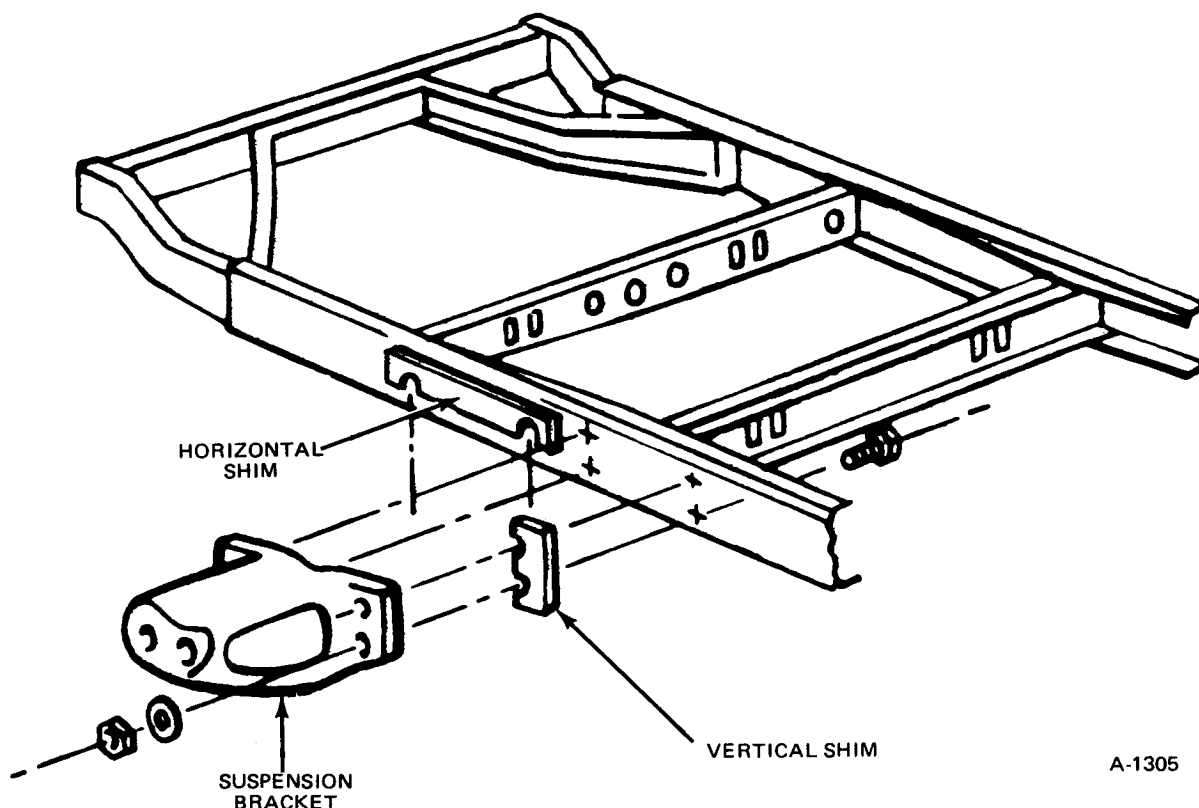
Figure 2 – Installing Rear Suspension Shims

If toe-in is not correct, it must be shimmed as shown in Figure 2. Follow this procedure for adjustment.

1. Raise vehicle off floor.
2. Loosen six bolts on mounting bracket.
3. Insert proper shims as shown in Figure 2.
4. Tighten four retaining nuts on frame rail to 65-85 lbs. ft. torque. Tighten two retaining nuts on crossmember to 50-80 lbs. ft. torque.
5. Lower vehicle to floor and roll backward and forward several feet.
6. Recheck alignment.

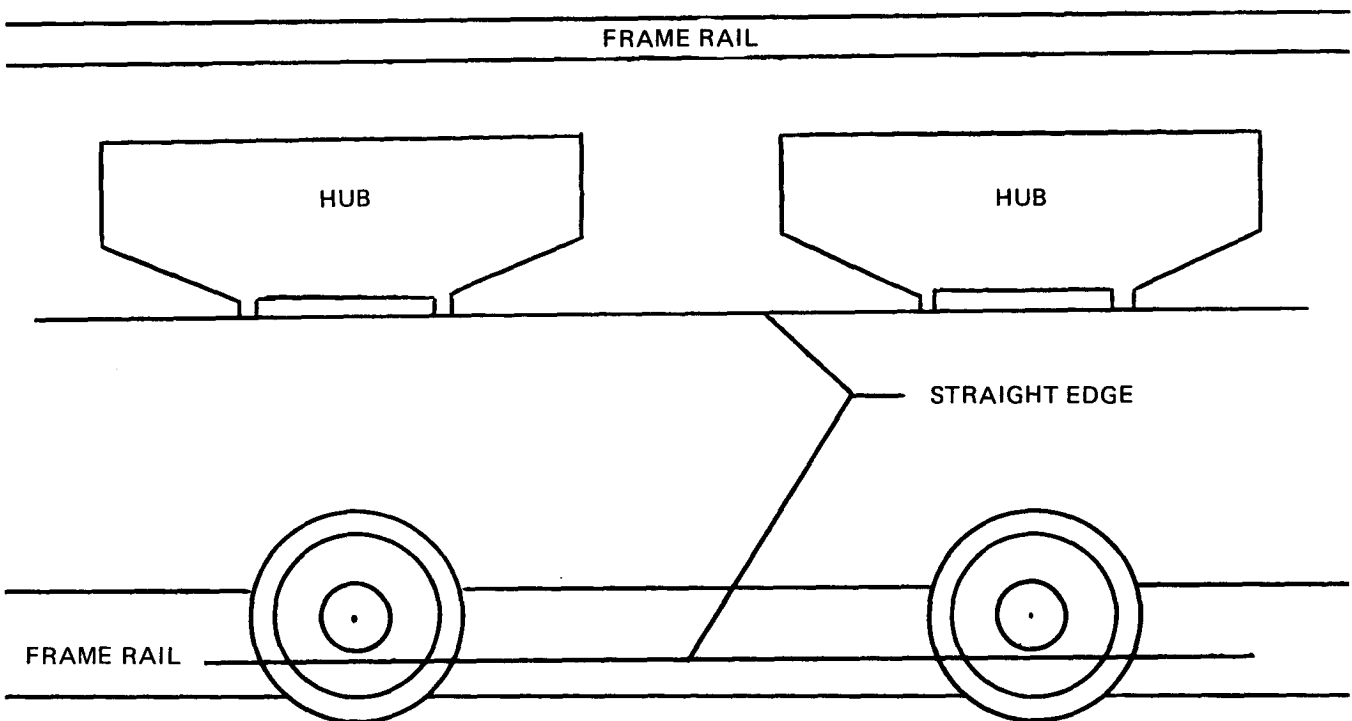
Figure 3 — Left or Right Rear Suspension

Bent Control Arm (Figure 3)

3. Place a straight edge across the face of the hubs as shown in Figure 3.
4. The straight edge should lie flat on each hub as shown in Figure 3. If the straight edge does not visibly rest on both points of each hub, a bent control arm will be evident and it should be replaced.

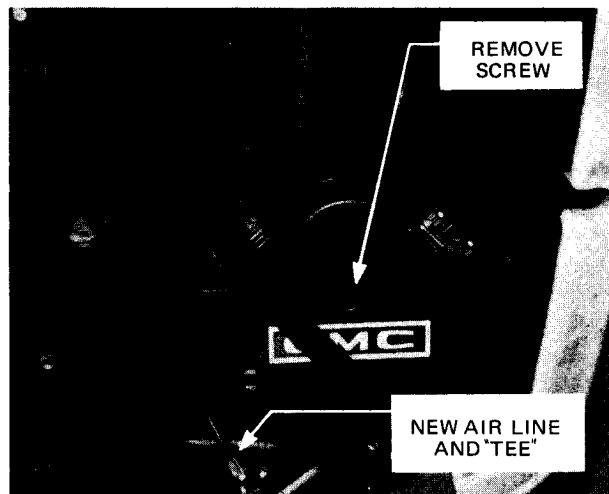
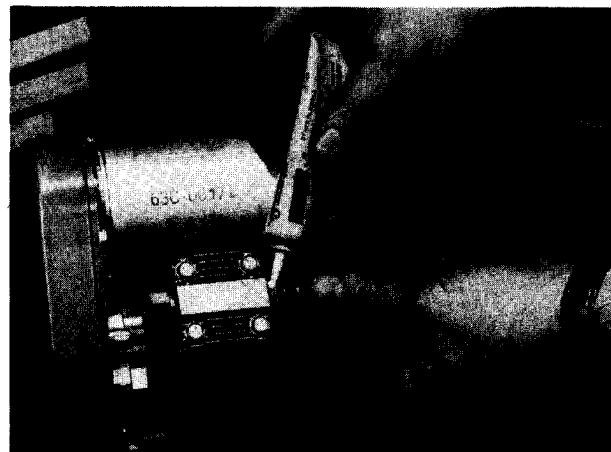
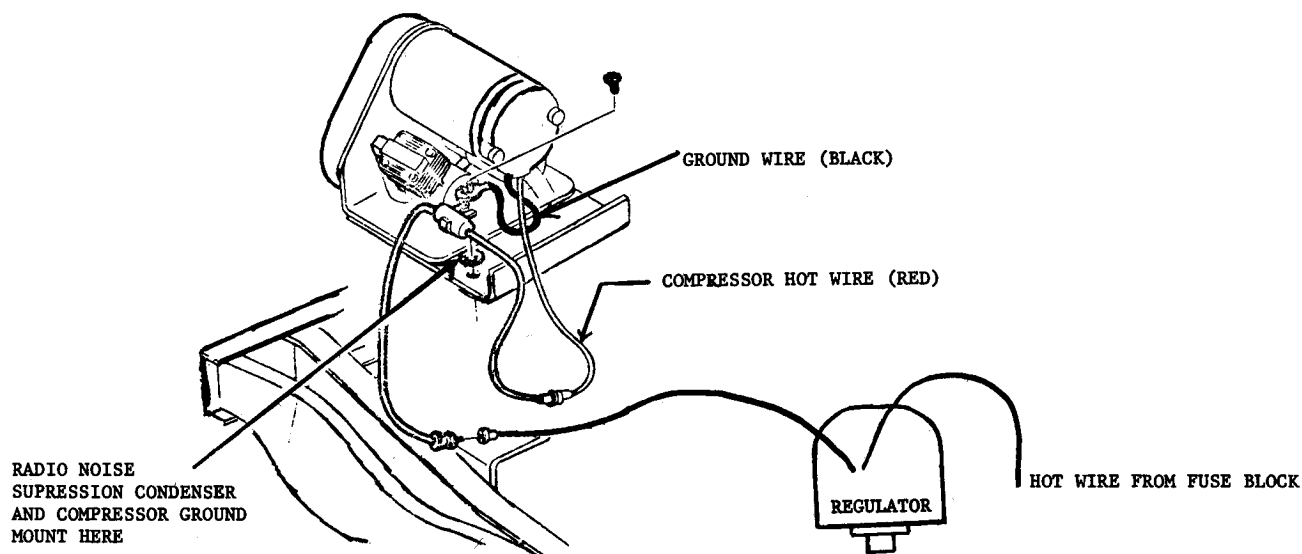
The Dana compressor, presently being used in production, is now available for service and can be used when replacing failed Brown compressors.

3. Using either a hoist or jack, slightly raise and support the radiator horse-collar to relieve pressure on the radiator mounting brackets in order that the compressor and its mounting bracket can easily be removed (Figure 1).

4. Remove all compressor mounting bracket attaching bolts. Remove compressor and bracket (Figure 2).
5. For easier installation, mount the Dana compressor (Part #795622) on the new bracket (Part #795261). The 90° flange on the mounting bracket goes to the rear.
6. Secure the new compressor and bracket. The new bracket has the same mounting bolt pattern as the former bracket.
7. Remove the hoist or jack supporting the radiator horsecollar.

9. Drill a 3/16" hole through the face of the regulator making sure not to hit any of the working components (Figure 3).
10. Using the drilled regulator as a template, mark the position on the left hand air conditioning condenser mounting bracket, which is attached to the radiator horsecollar, to show where to drill a 3/16" hole for mounting. Drill hole.

11. Using a machine screw, lock washer and nut; mount the regulator. It is desirable to mount the regulator on a slight angle in order to facilitate future adjustments on the regulator if required (Figure 4).
12. The air line from the regulator should be plumbed into the air line going to the rear wheel air bag, if this has not already been done as described in previous Technical Service Bulletin 74-TM-7 in Group 4 - Rear Suspension. This is done using either a brass or nylon tee. A piece of new air line may be required to achieve proper length (Figure 5).

13. Screw fitting (Part #652628) into the left hand head of the new compressor. Use a good sealer on the thread (Figure 6). There will be a red plastic plug in the head which is to be removed. Connect the air line running between the compressor to the reservoir. An additional piece of air line may be required to achieve proper length (Figure 7).

15. Wire compressor and regulator as shown (Figure 8). Standard wire splices may be used instead of the connectors shown.

CAUTION: If compressor is wired backwards, the rotation of the pump will be backward causing severe damage to the compressor. Check compressor rotation by removing front cover and viewing.

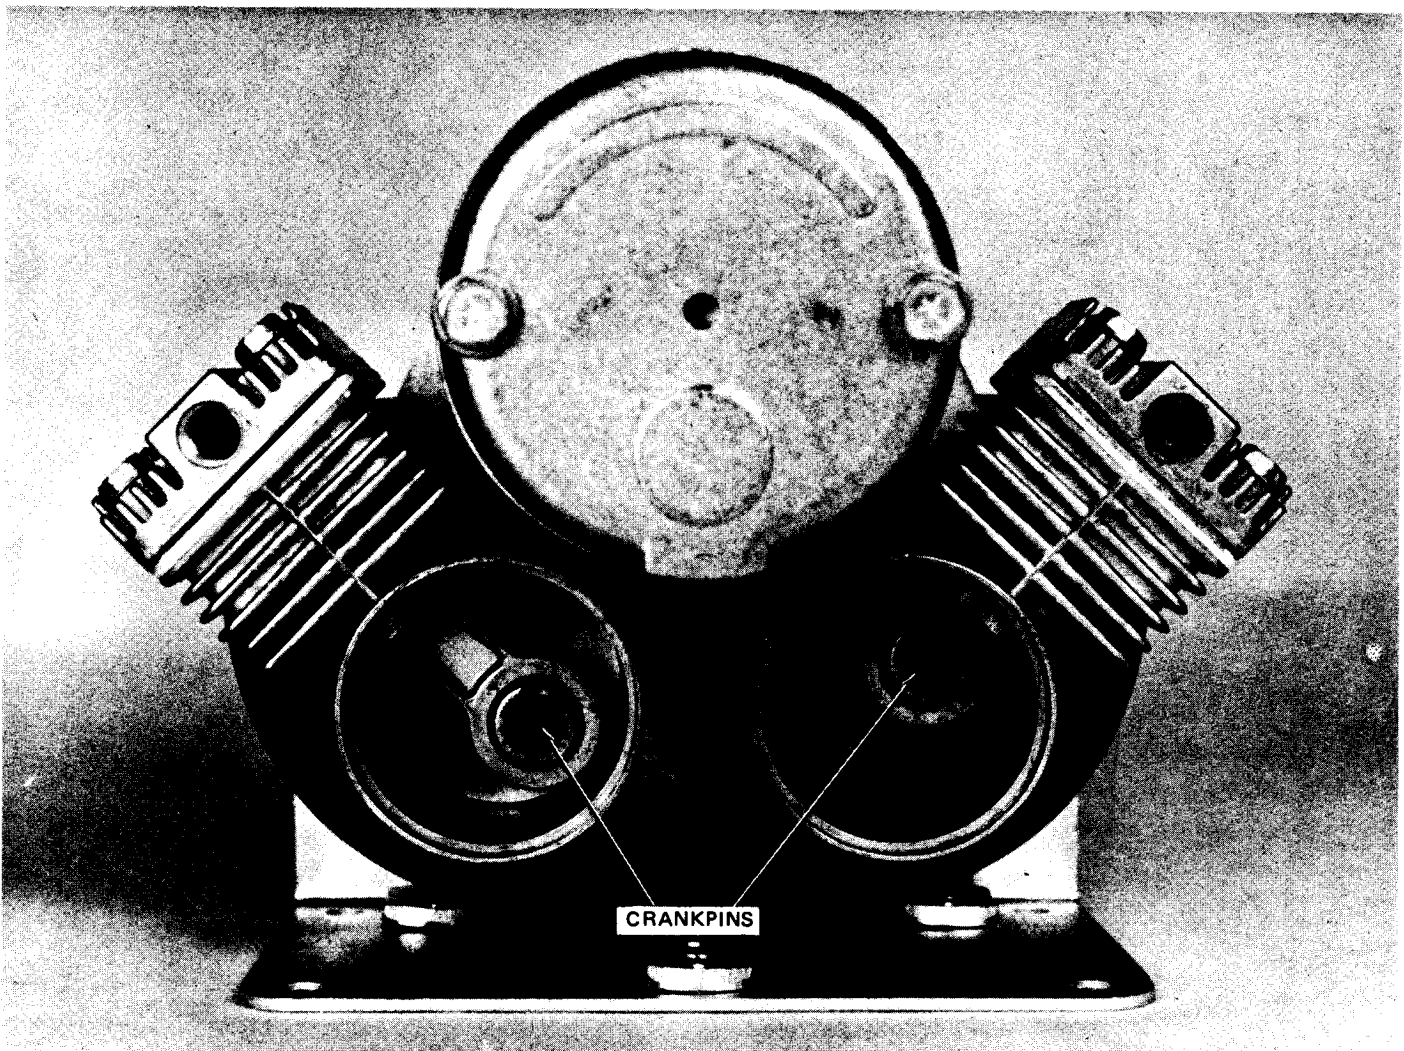
On some replacement Dana air compressors, crankpins have been backing out of the crankshaft and causing compressor failures. This problem has been evident on compressors built prior to May 26, 1976. The assembly date is stamped on the side of each compressor motor in black numerics.

The crankpin torque should be checked on all replacement Dana air compressors built prior to May 26, 1976 and torqued to 95 in.lbs. The crankpins are torqued by removing the air intake assembly and securing the crankpin to the lower end of the connecting rod with a hex key wrench.

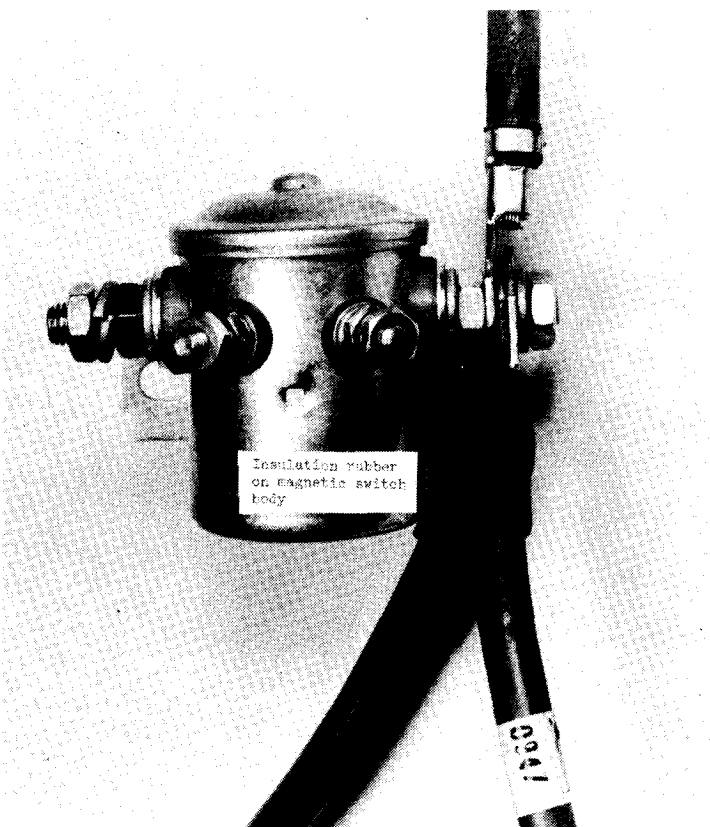
INCORRECT METHOD OF TERMINATING CABLE ENDS

Technical Service has received information that battery and starter cables terminating at the magnetic switch located on the fire wall as well as the wires terminating at the living area magnetic switch located in the battery compartment may have been improperly installed on some vehicles by dealers. If the cables are installed incorrectly, a ground may be created to the magnetic switch.

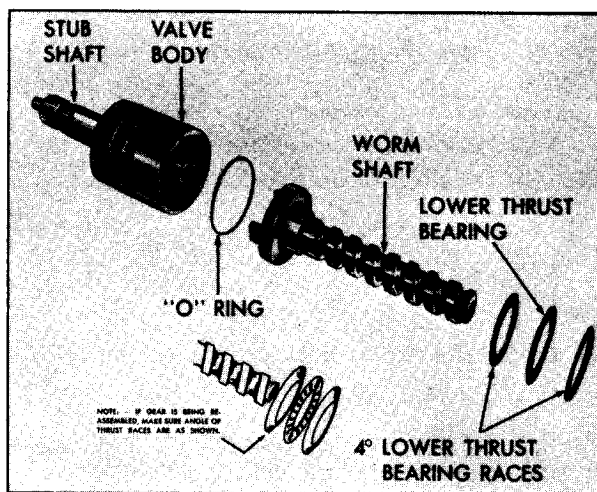
Motor home steering gear assemblies will incorporate a new input shaft lower thrust bearing configuration. The thrust bearing itself remains unchanged, but both bearing races are conical, and essentially become axial spring washers to prevent loss of thrust bearing preload. See Figure 1.

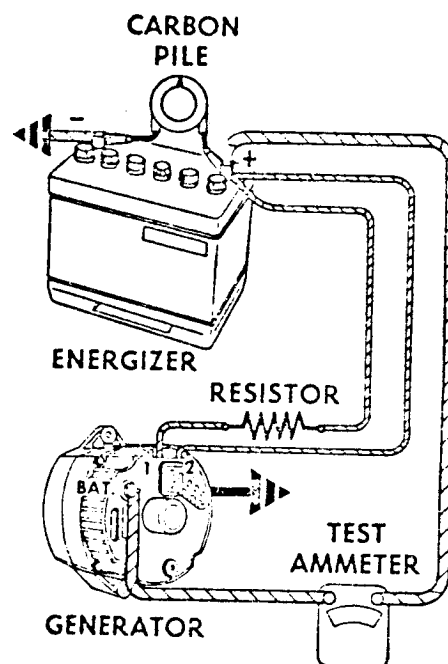
TEST CIRCUIT

Technical Service has received several reports of the generator telltale light glowing dimly at all times. This condition can exist even though the alternator is operating correctly. It may be caused by a partially discharged vehicle battery or by the small voltage drop across the dual diode isolator.

1. Disconnect the battery ground cable.
2. Connect an ammeter in the circuit at the "BAT" terminal of the generator (see illustration).
3. Reconnect the battery ground cable.
4. Turn on radio, lights high beam, and blower motor high speed. Connect a carbon pile across the battery (see illustration).
5. Operate the engine at a moderate speed as required, and adjust the carbon pile as required to obtain a maximum current output.
6. If ampere output is within 10% of rated output (80 amps) generator is not defective.
