MOTORHOME SERVICE BULLETINS INDEX

TRUCK & COACH DIVISION
GENERAL MOTORS CORPORATION
Pontiac, Michigan 48053

**INDEX
OF
GMC MOTORHOME SERVICE BULLETINS**

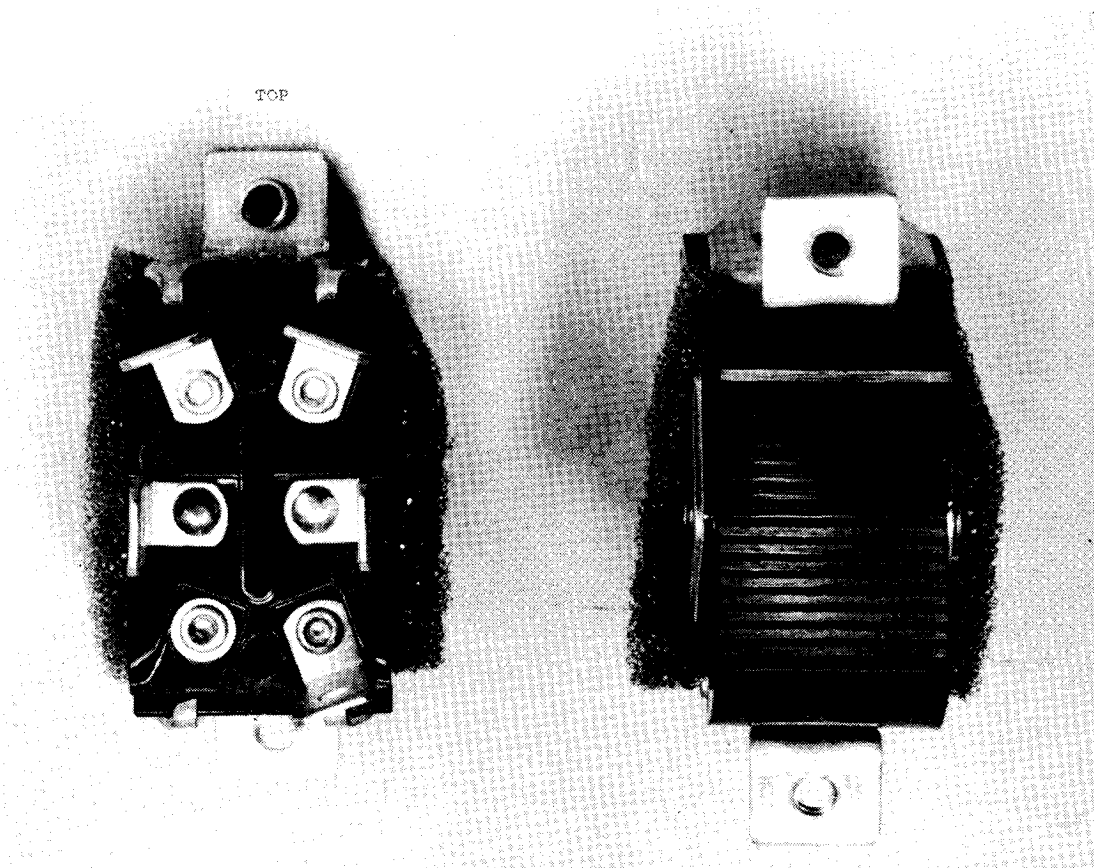
It has been found that it is possible to install the battery boost switch on the instrument panel upside down. This will cause the batteries to be connected in the boost mode when the switch indicates that they are in the battery normal mode.

The top of the switch is the end with two connector terminals. The bottom has only one terminal (see illustration). If a chronic complaint of the vehicle battery being drained by the living area facilities is encountered the installation of this switch should be checked. Care should be taken when installing a new switch to be sure it is right side up.

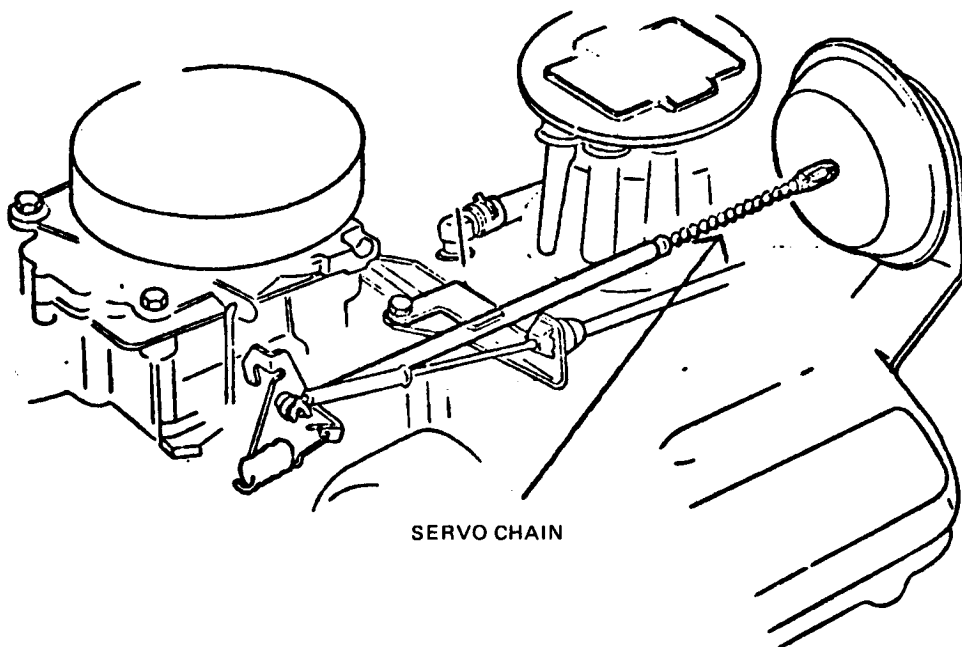
SERVO CHAIN

Excessive slack in the cruise control servo chain has been encountered on several GMC Motorhomes. This condition is most evident when the motor home is ascending a hill and the vehicle speed drops off several miles per hour.

The servo chain slack can be eliminated by shortening or adjusting the servo chain length at the servo unit end to minimum slack with the carburetor on slow idle cam and the engine not running.

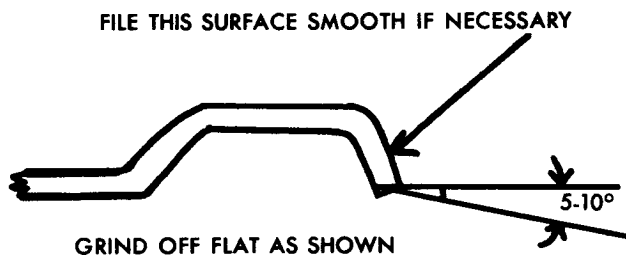
LATCH STRIKER (PART NUMBER 101602)

Some reports have been received concerning subject doors becoming unlatched while the motor home is in motion. The following procedures are suggested to rework latches when this condition is encountered:

1. Remove the latch assembly from the door and grind the striker end flat as shown in Figure #1. In some cases, it will be necessary to hand-file the excessive tool marks off of the back side of this striker also.
2. Depending on the door fit and the amount of metal removed in Step #1 above, it may be necessary to remove the catch plate and bend it as shown in Figure #2 to provide a snug fit of the latch striker behind the catch when the door is closed. The catch should be positioned so that the locking lip covers the entire ground surface of the striker with the door shut and the striker fully extended. Make sure the door hinge attaching screws are tight also.

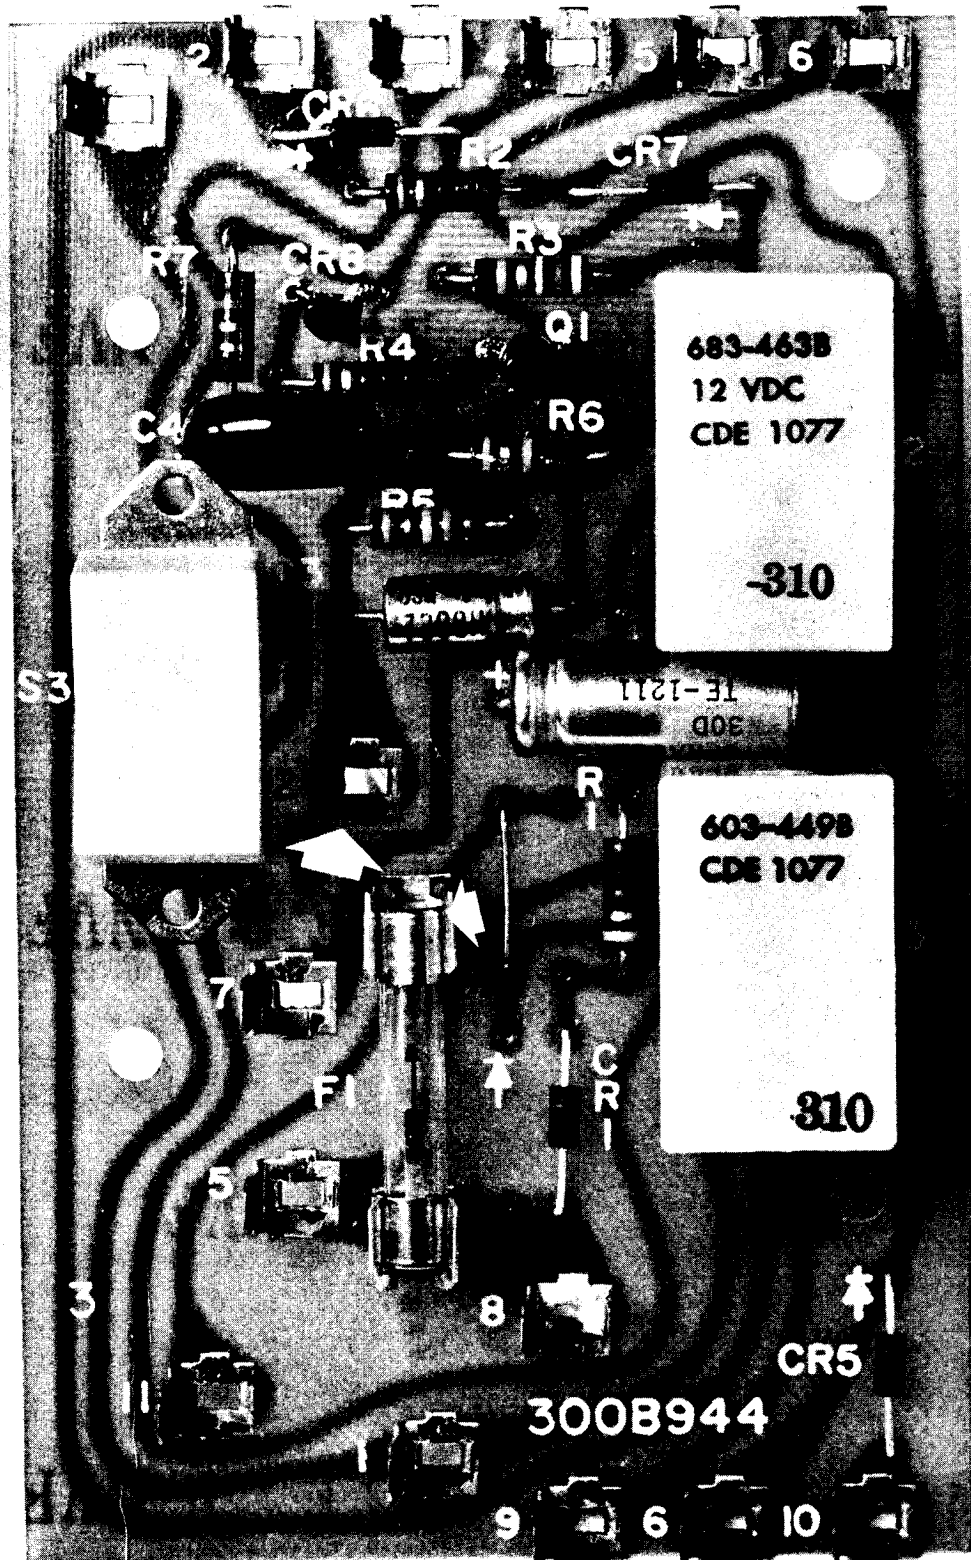
This Path Burns

A number of Onan printed circuit boards (Pt. #707144) returned on warranty have been damaged during trouble shooting. The most common damage has been burning off the path between the F1 fuse and terminal 11. This damage is caused by grounding the fuse terminal which is in the path to terminal 11. It appears this damage is caused when a screwdriver is used to remove the fuse and touches terminal #12 which goes to ground (see illustration).

It is recommended that when work is being done on the board, which does not include reading voltages, that the battery be disconnected. It would also be advisable when removing a fuse to use a standard plastic fuse puller and installer which is available at any auto parts store.

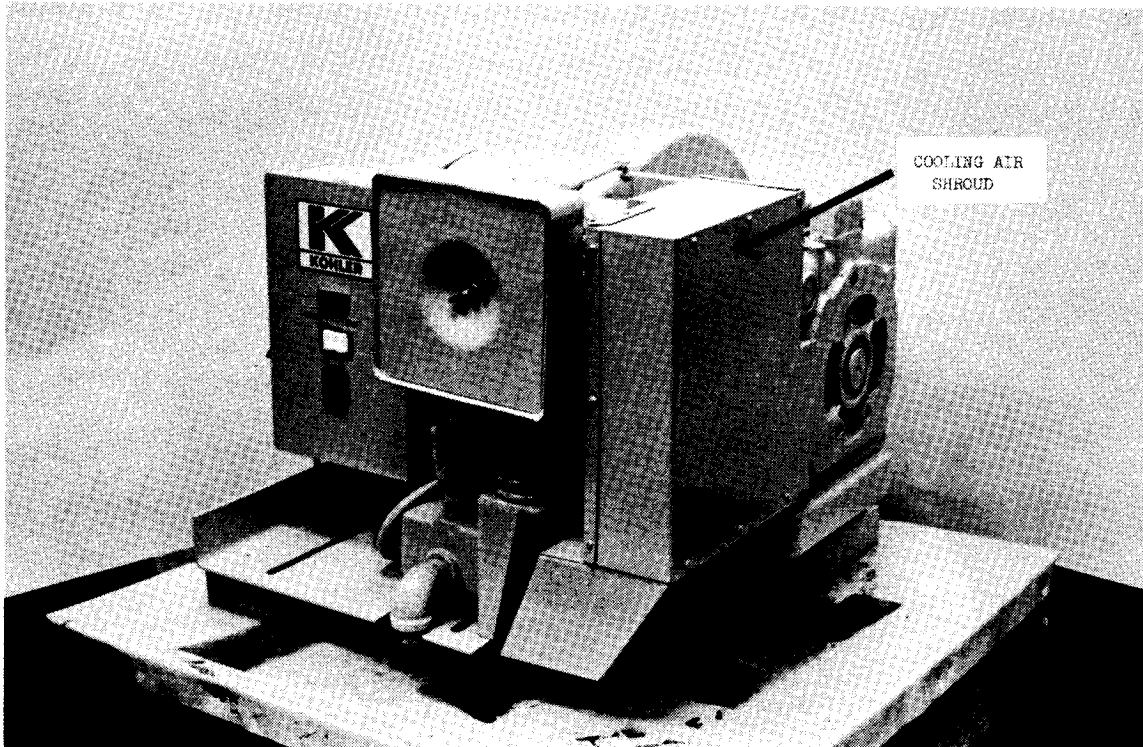
Discoloration of the paint on the cooling air shroud is normal and does not affect the operation of the unit. Heat from the exhaust manifold, which is contained inside the shroud, may cause some discoloration.

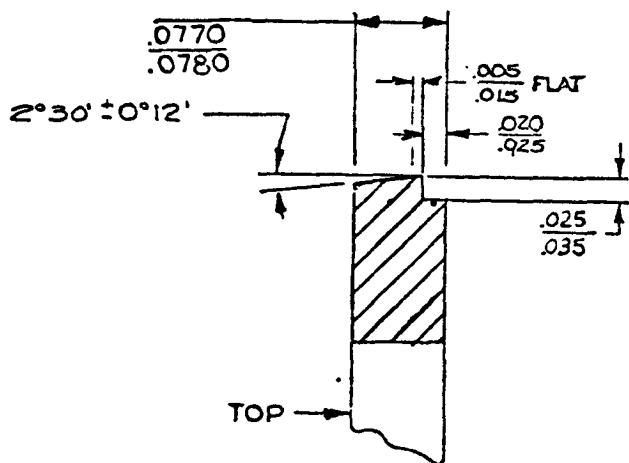
NEW STYLE COMPRESSION RING

The most significant change in the rings is in the top compression ring. This ring is shaped differently and is slightly thicker (see illustration). The other change is that the oil control ring now has only seven drain slots instead of the former eight slots.

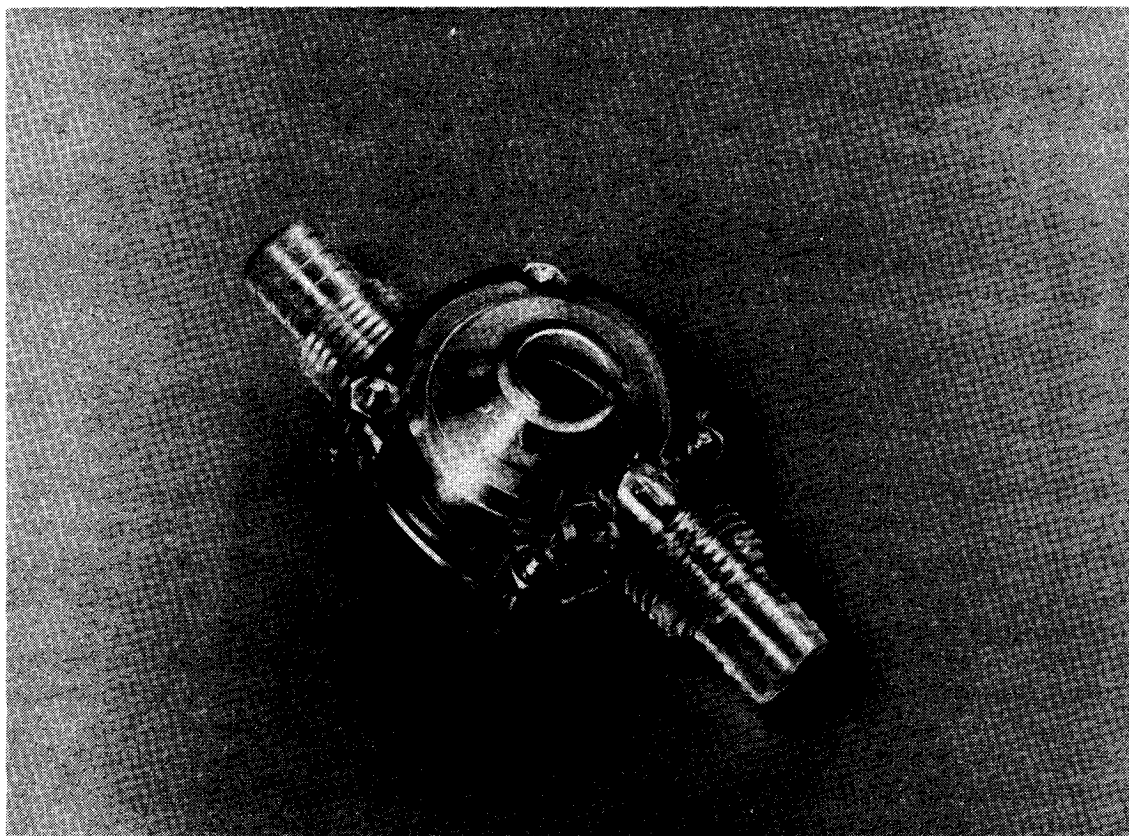
It is possible that fresh water pumps may be damaged when foreign material enters the valves in the pump. When such a situation is encountered, it is recommended that a newly released in-line water filter, part #790334, should be installed. Before installation the tank should be flushed out and the water pump valves cleaned or replaced.

The filter should be installed in the hose coming from the water tank to the pump. There are arrows imprinted on the valve to show the direction the water should flow.

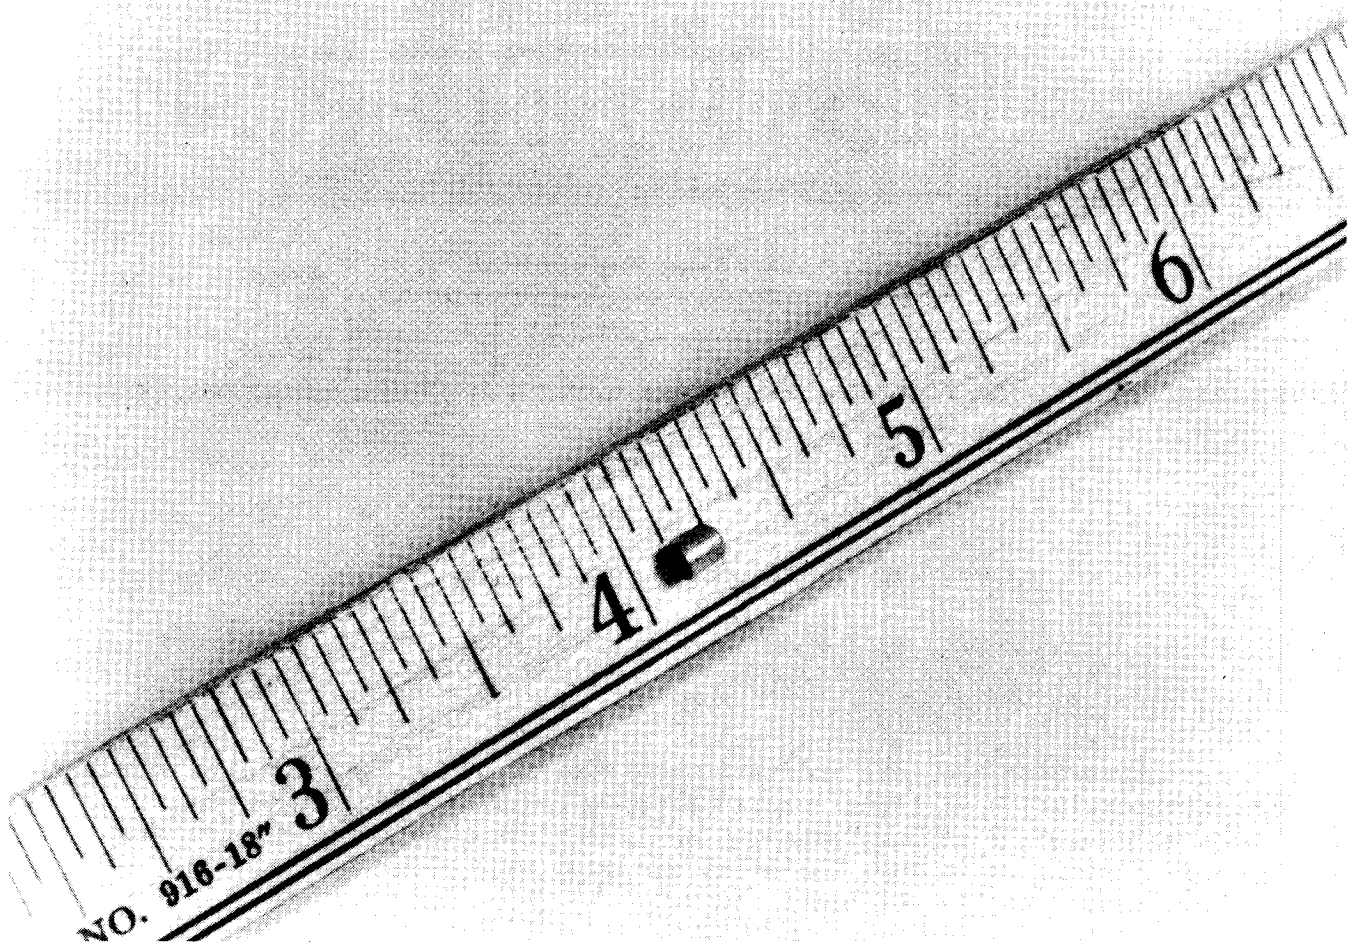
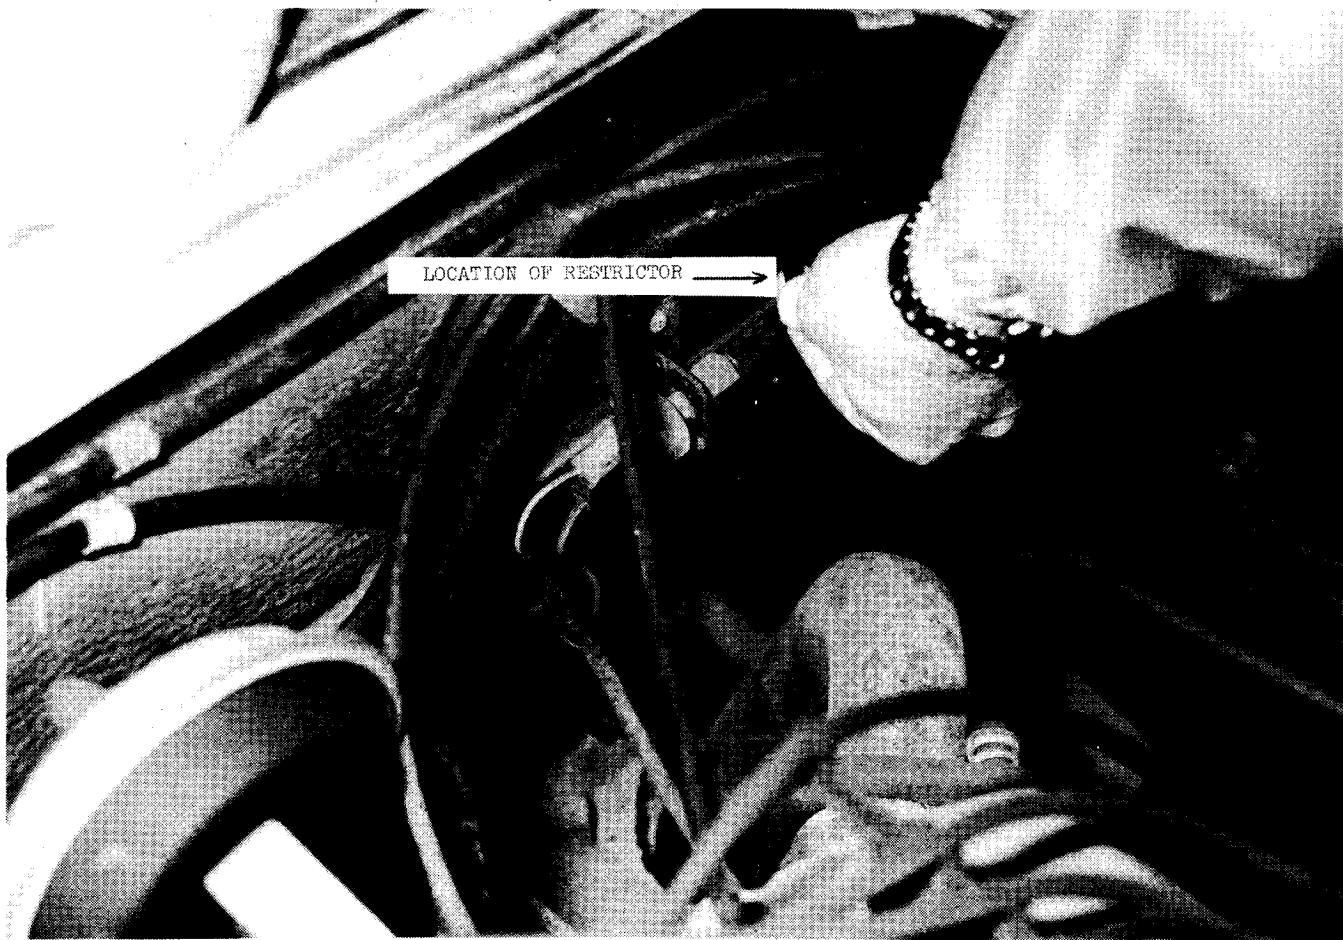
Recent service contacts indicate that some of our dealers are not aware of the inline restrictor located between the manifold and the vacuum sensor assembly on the Thermasan unit. It has also been reported that this restrictor in some instances has been removed by servicing dealers. This restrictor is not to be removed.

The function of this powdered metal restrictor is to create a positive action of the vacuum sensor assembly. Without the restrictor, there will be a clicking sound in the control head on the dash panel. Also, the red reaction light will flicker on and off during acceleration and deceleration at approximately the 30 MPH range.

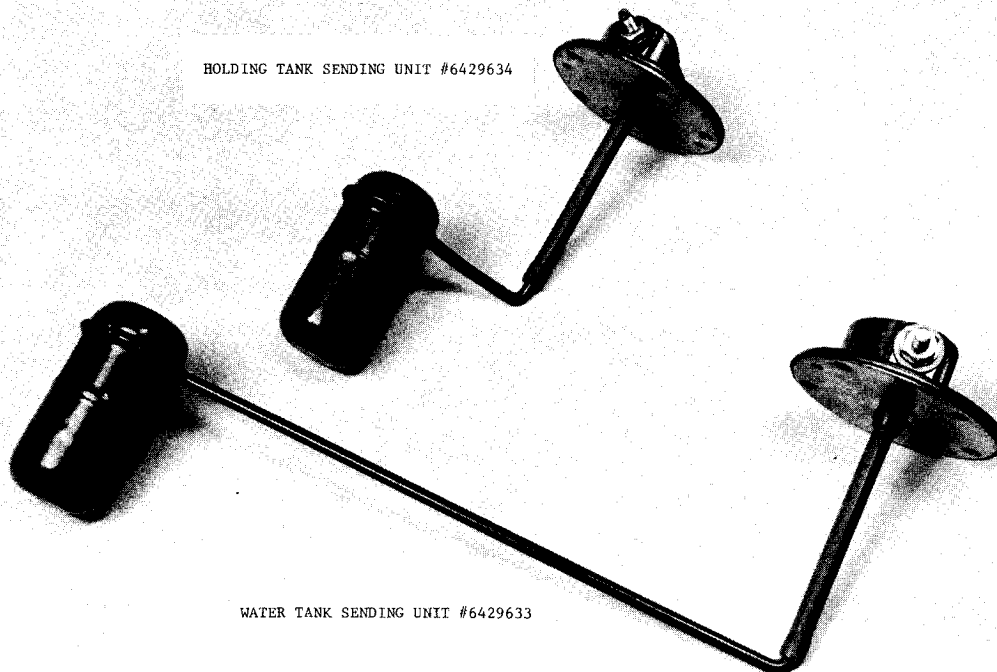
Interchanging of the water tank and holding tank sending units must be avoided. Although both sending units and their gauges are similar, the pivoting action of the floats differ.

Therefore, in order to have the gauges on the monitor panel read correctly, it is important that the proper sending unit be used at all times.

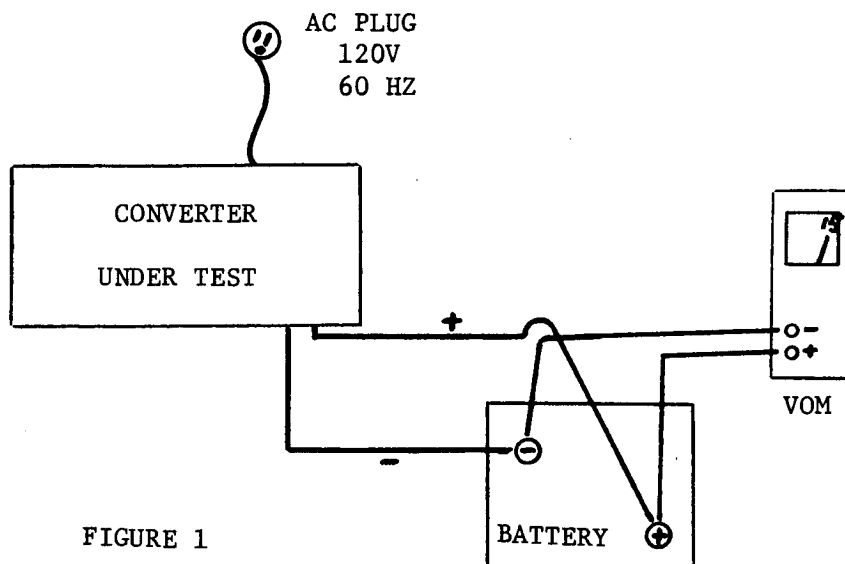
FIGURE 1

Many Triad-Utrad converters returned to us for warranty credit, when tested, have proven to be in good operating condition. Before a converter is replaced, it should be tested in the following manner:

Converter humming is not considered to be a failure. Humming should be corrected by installing mounting pads as described in Dealer Service Technical Bulletin 75-TM-14 dated March, 1975.

1. Check the motor generator frequency setting. It should be 63 cycles at 120 volts no load. The converter is sensitive to frequency and will not function properly below 60 cycles. If you plan to bench test the unit, make sure the wall socket is producing 60 cycles. This can also be checked with your frequency meter.
2. Disconnect the converter leads from the motor home. This assures that only the converter is being checked.
3. Connect the leads to a good, fully charged, battery and plug in the converter (Figure 1).
4. Using a good calibrated voltmeter, read output voltage across the battery. It should be between 13 to 15 volts.

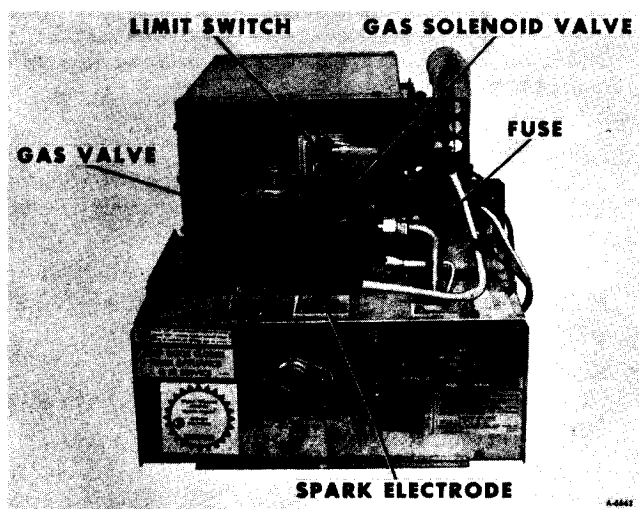
Figure 3 – Furnace Components (Front View)

The gas solenoid valve (Figure 3) controls the flow of LP gas to the burner assembly. Opening and closing of this valve is controlled by the sail switch and the ignition system.

The following components (Figure 3) can be inspected and replaced without removing the combustion chamber assembly from the vehicle.

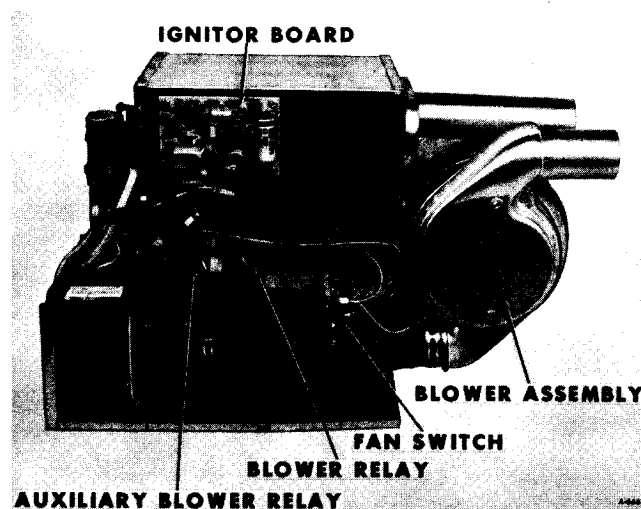
Figure 4 – Furnace Components (Side View)

The fan switch (Figure 4) controls the sequence of blower operation. The fan switch is a two pole switch. When the bimetal disc in the switch is heated to operating temperature, the switch changes position. The blower will continue to run as long as the circulating air chamber is hot, even though the thermostat contacts are open and the gas solenoid valve is closed. When the chamber cools, the fan switch changes back to its original position and shuts the blower off.

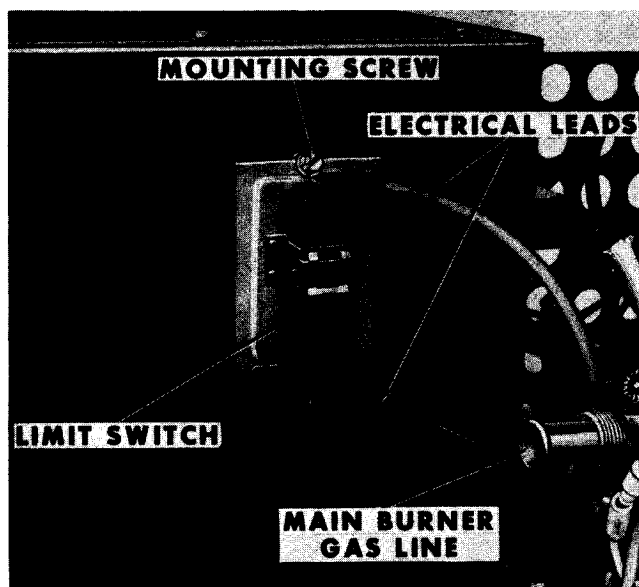
Figure 12 – Limit Switch Installed

The limit switch function is to turn off the gas supply to the burner assembly if furnace temperature exceeds the high temperature limit of 200°F (93°C). If this temperature is exceeded during furnace operation, the limit switch will open causing the gas solenoid valve to close, thus shutting off LP gas to the furnace.

2. Disconnect electrical leads from limit switch (Figure 12).

3. Remove limit switch mounting screw. Carefully remove limit switch from combustion chamber assembly.

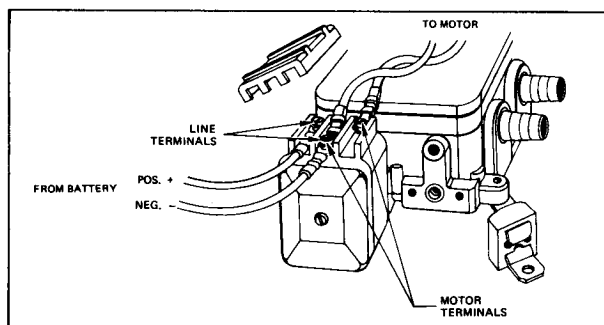
Figure 2

- If the pump draws current from two alternative power supplies (battery or AC-DC converter), a voltage check must be made for each operational mode. Voltage reading at the pump must not fall below 10.5 volts.

- Turn on all electrical fixtures inside the vehicle.
- Fully open a faucet.
- Using a DC voltmeter, read the minimum voltage across the line terminals on the pressure switch. (Figure 2)

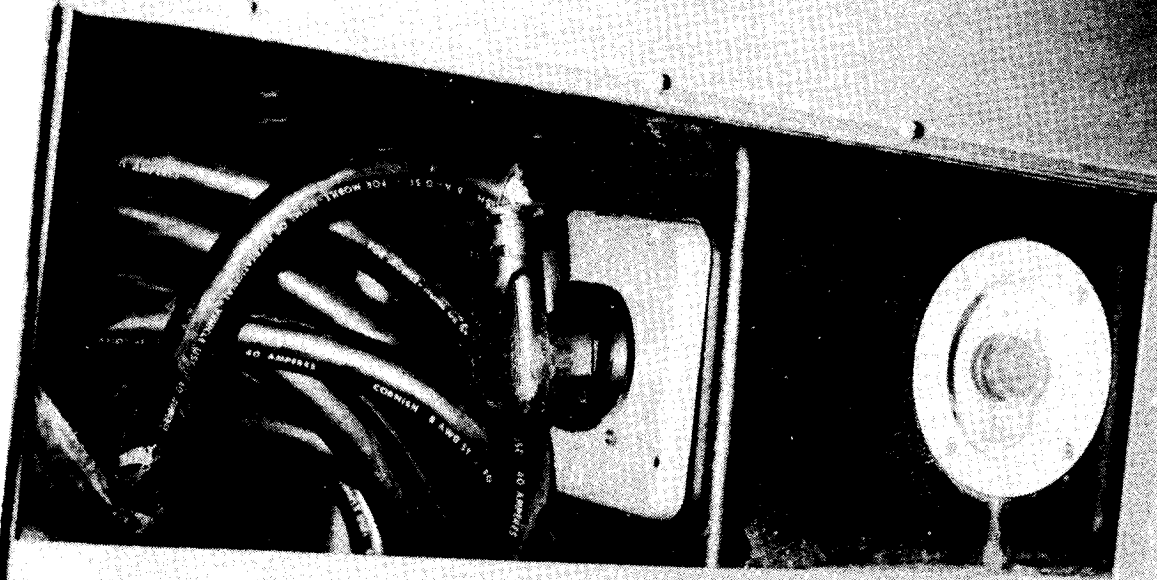
FIGURE 1

In the event the AC power cord binds against the top of the external utilities compartment (see Figure 1) it might prevent the plug from being completely inserted in the receptacle.

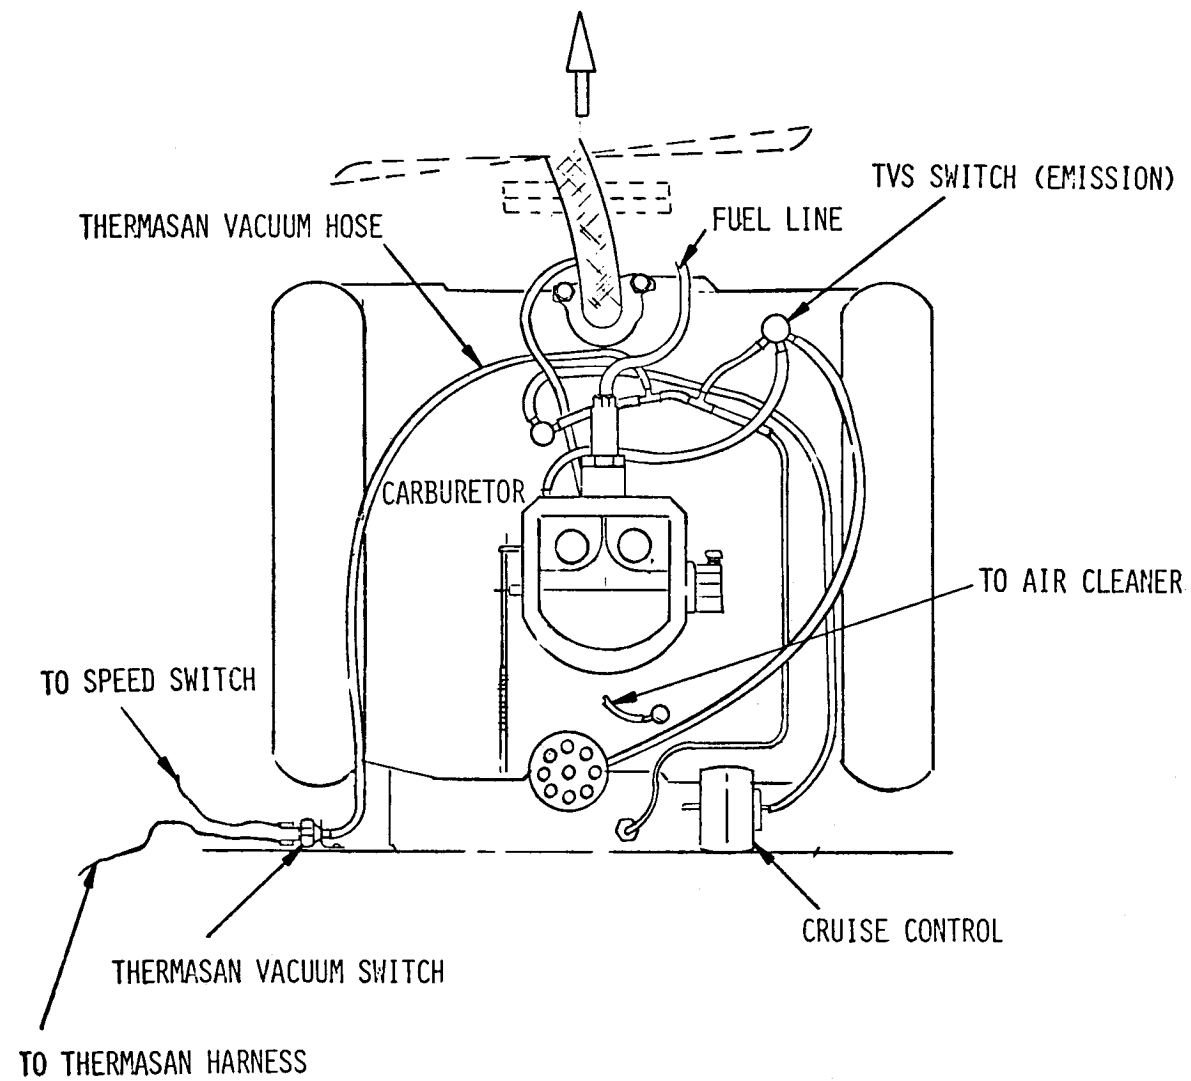
It has been brought to the attention of the Technical Service Department that a number of motor homes equipped with Thermasan were delivered with the Thermasan vacuum switch supply hose incorrectly tapped into a vacuum source. Reports indicate that the switch has on occasion been tapped on to the vacuum hose coming from the distributor or the Thermac air cleaner would give insufficient vacuum. What is needed is a constant source of vacuum down from the manifold.

The line drawing shows the correct routing and tap-in of the Thermasan vacuum switch.

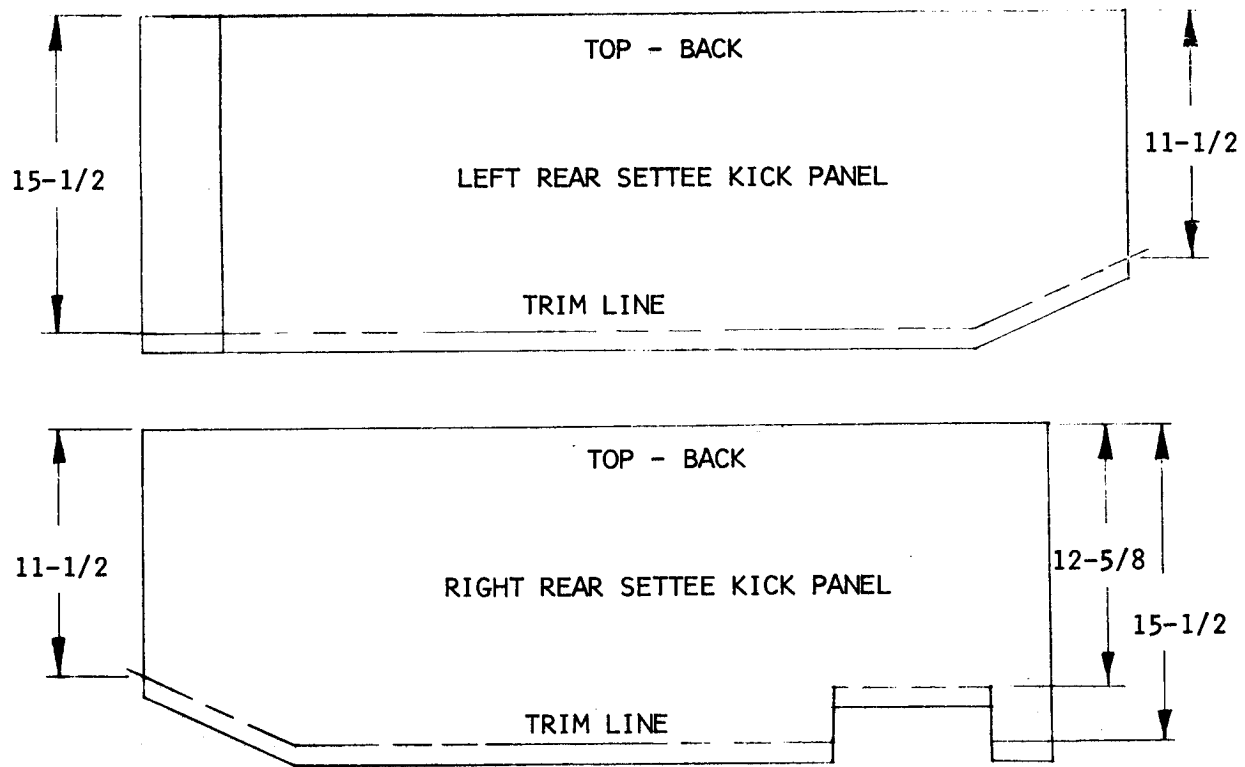
FIGURE 1

The rear settee kick panels on some 1975 model Eleganza II Motor Homes may interfere with the settee bottom support channels. Also, the "velcro" used to hold the kick panels in position may tear from the panel. To correct these conditions, do the following.

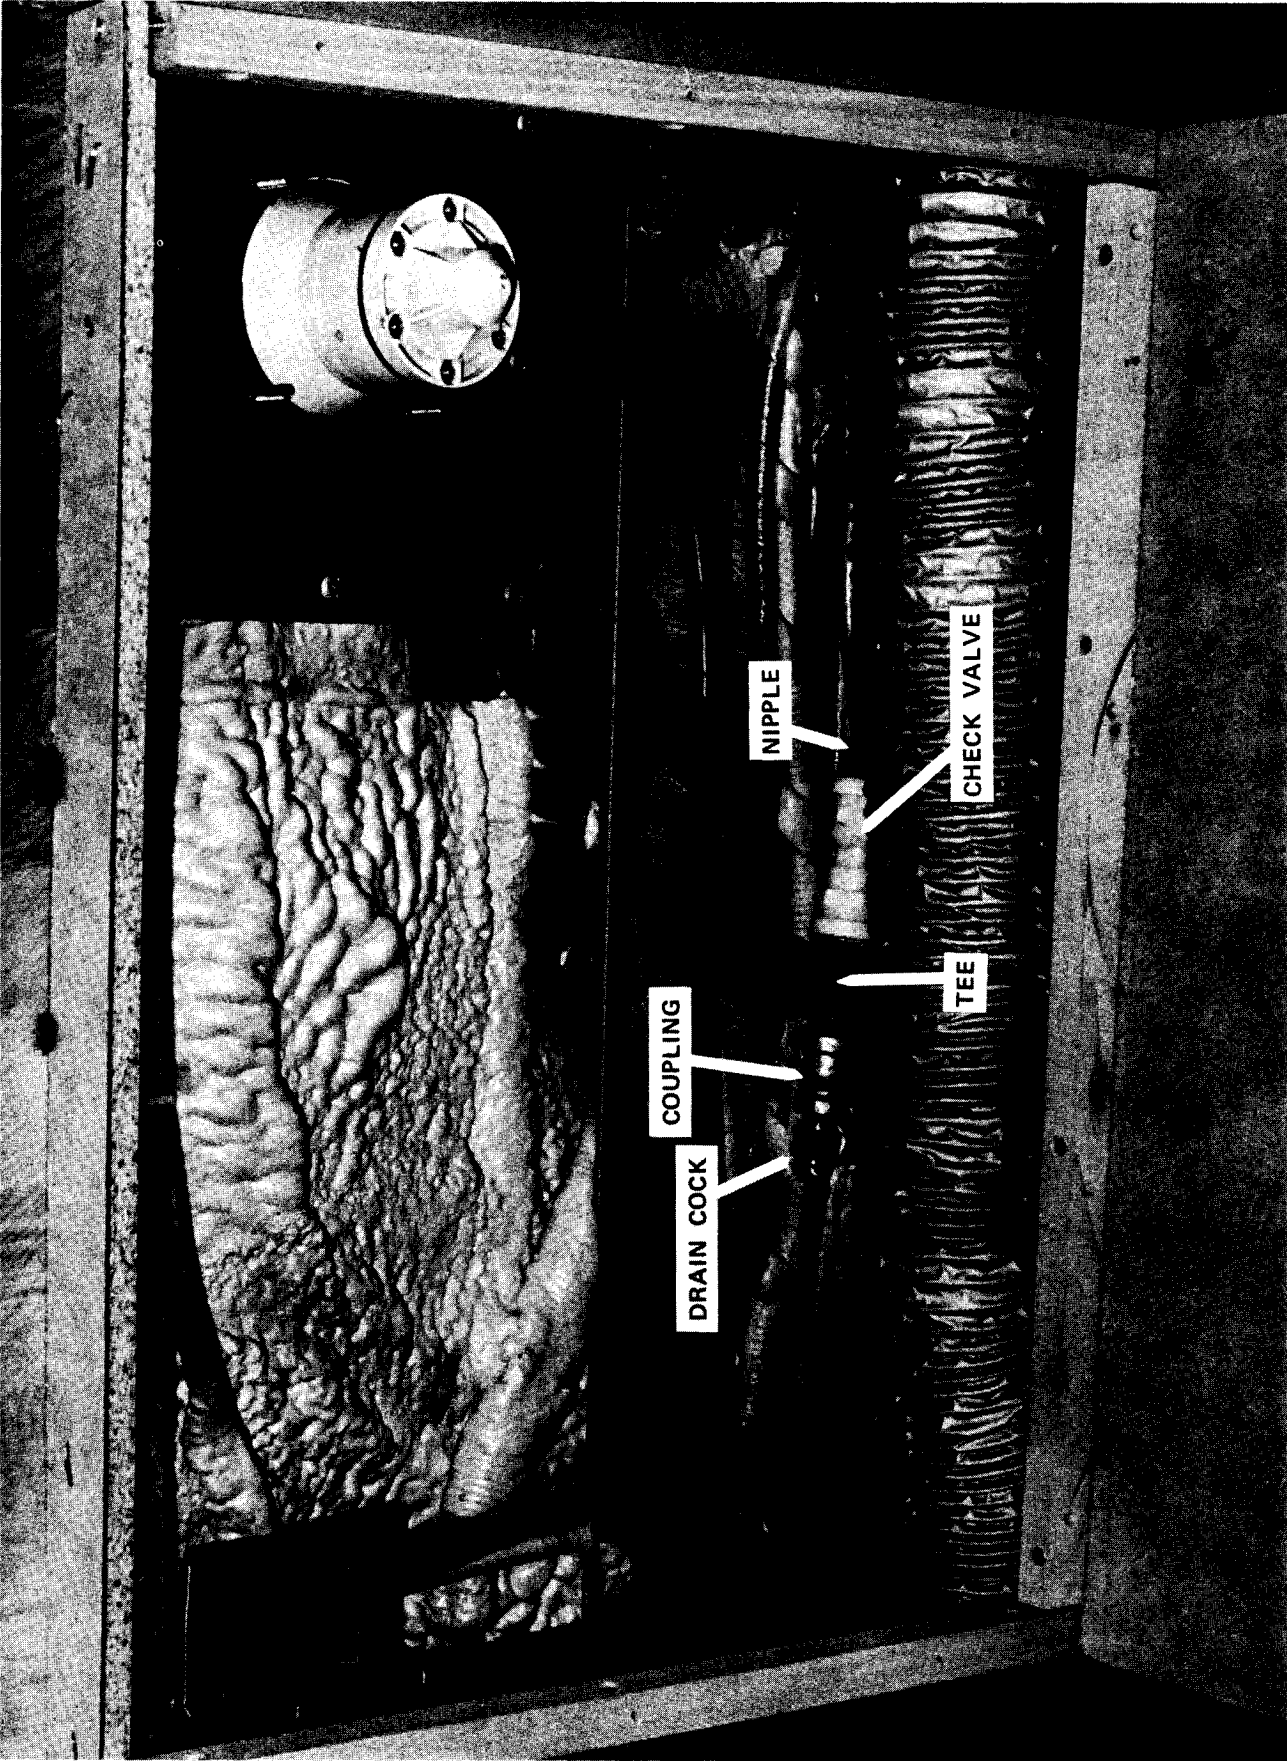
FIGURE 1

A check valve and drain cock have been added to the 1975 model GMC Motor Home city water line. The addition of the drain cock allows water to be drained away from the city water valve so that the valve will not be damaged by freezing. All 1975 model motor homes should be modified to prevent freezing of the city water valve. However, 1973 and 1974 model motor homes should be modified only when the city water valve requires replacement.

8. Install line to check valve tee and city water valve as shown in Figure 1.
9. Drill 3/4" diameter hole below drain cock through wheelhouse with hole saw. DO NOT DRILL THROUGH WIRING.
10. Install 6" of hose to drain valve with hose clamp and seal to wheelhouse with silicone caulk type sealant as shown in Figure 1.
11. Close galley drain valve and galley cold water.
12. Connect vehicle to city water, run water at galley and inspect and correct leaks as necessary.
13. Disconnect vehicle from city water (leave dust cap off).
14. Open and close city water drain valve.
15. Tape template "A" (Figure 2) on city water valve access panel. Drill a 3/8" diameter hole and make cuts with saber saw as shown on template. Break sharp edges on hole.
16. Reinstall city water valve access panel.
17. Restaple carpet to panel.
18. Cut carpet to match opening of access hole as shown in Figure 3.

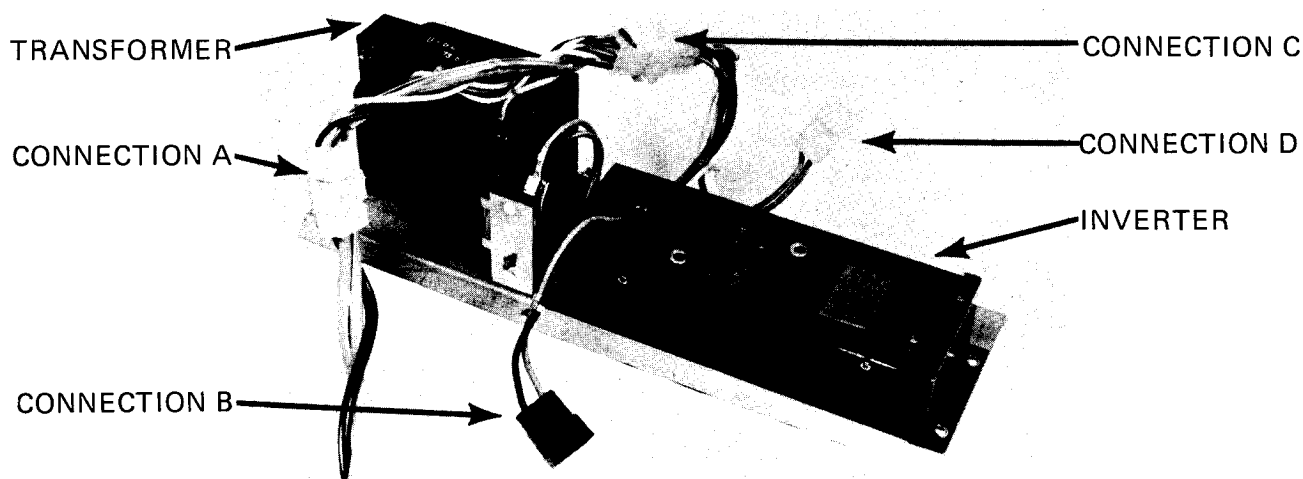
Figure No. 1 — Norcold Inverter Assembly

Effective with this bulletin, the inverter assembly transformers or inverters may be replaced as individual components rather than as a complete assembly.

2. If connections check out, replace the thermostat.
4. Transformer Check (Refer to Figure 1).
 - A. Secondary Windings
 1. Separate connection "A".
 2. Connect the positive ohmmeter lead to the blue transformer lead and connect the negative ohmmeter lead to the yellow transformer lead.

3. The ohmmeter should read approximately 3/4 Ω . If not, replace the transformer. (Transformer Part No. 2011860).
- B. Primary (117V Winding) (Refer to Figure 1).

- D. Separate connection "B".
 - E. On the inverter side of connection "B", connect the positive ohmmeter lead to the red wire and the negative ohmmeter lead to the black wire. A reading of approximately 35 Ω should be indicated. However, any reading in the range of 4 Ω to 60 Ω is acceptable. If not, replace the inverter. (Inverter Part No. 2011861).

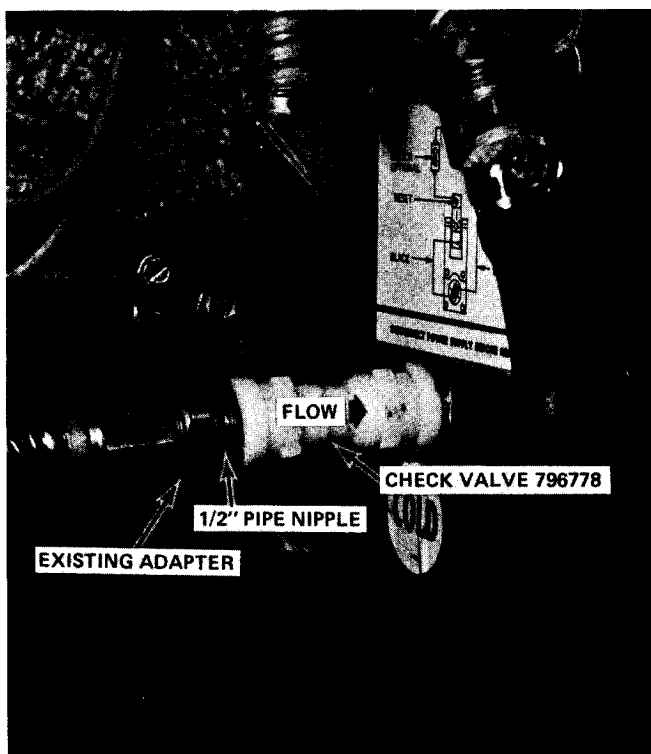
Figure 1

After periods of sustained driving, it has been found that the water heated in the water heater by the engine tends to back up into the cold water system. This bulletin details the procedure for installing a check valve in the cold water line just before it enters the hot water heater. This will prevent hot water from entering the cold water system. This check valve became standard equipment effective with TZE166V100529.

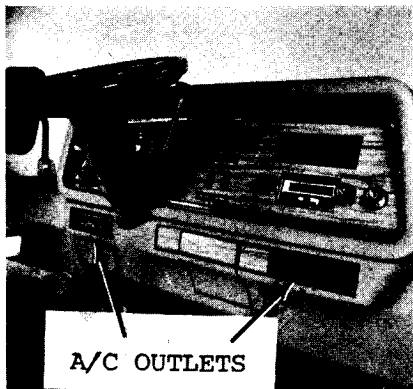
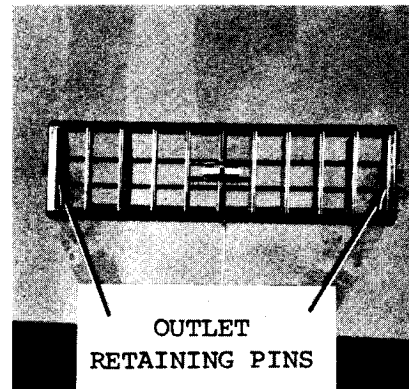
In some cases, the air conditioning outlets in the L.H. valence panel will not secure properly and a resultant looseness occurs. This is caused by the outlet retaining pins not seating properly in their respective bezel mounting holes. Thus, in a relatively short period of time, the retaining pins take a set in the outlet and looseness occurs.

- . Remove with a file any excess flashing from the outlet bezel mounting holes.
- . Submerge the affected outlets in hot water for a few moments.
- . Remove the outlets from the hot water and hold the retaining pins out with a screwdriver. After the retaining pin cools, it should retain its proper position.
- . Reinstall the outlets in the outlet bezel mounting holes.
- . Check to see if the outlets fit properly and correct as necessary.

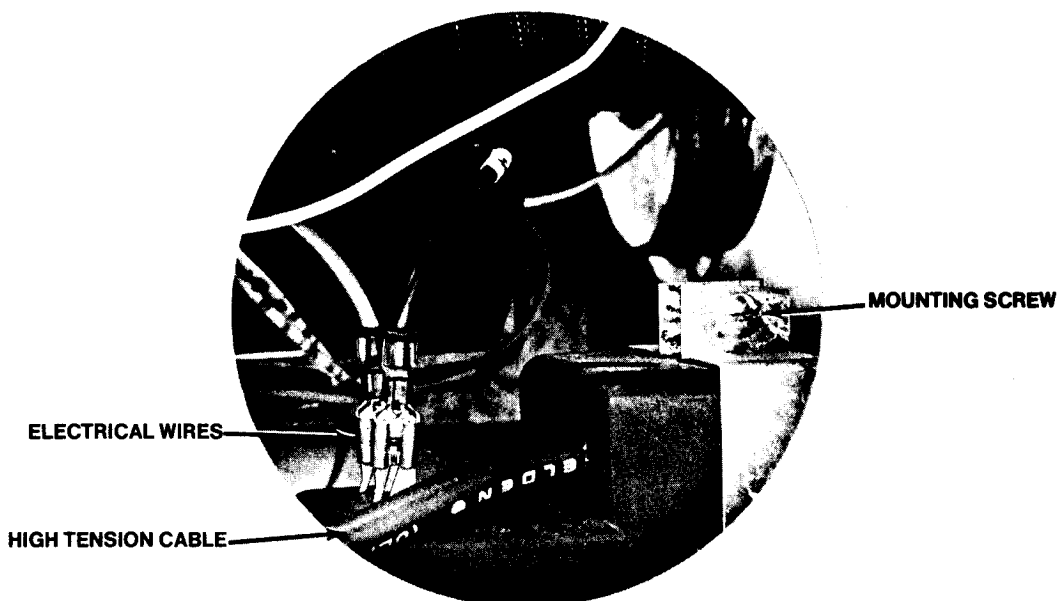
Figure 1

This bulletin is intended to provide information for simplifying the service procedure required to remove and replace the ignition pak. This will replace the procedure in Maintenance Manual X-7525, Page 24G-13.

1. Disconnect furnace duct from right side of furnace.
 - A. If vehicle is equipped with davo, raise seat and then disconnect duct from right side of furnace.
 - B. If vehicle is equipped with swivel chairs, remove retaining duct panel assembly to floor. Carefully raise panels and disconnect duct from right side of furnace.
2. By reaching through duct opening, disconnect high tension cable (Figure 1) from ignition pak.
3. Disconnect two electrical wires from ignition pak (Figure 1). Be sure to note which terminal each wire is removed from to aid in proper installation.
4. Loosen mounting screw and remove ignition pak.

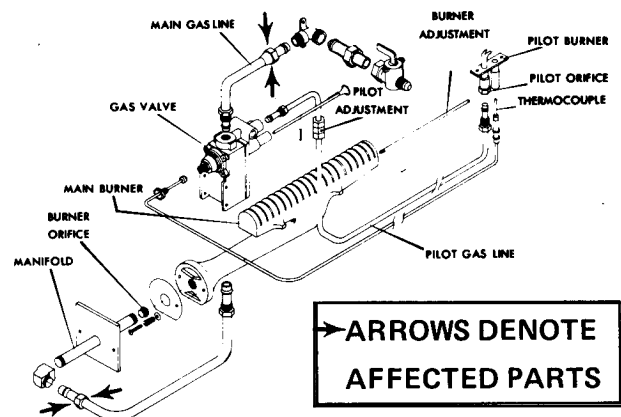
Figure #1

The defect involves corrosion stress cracks which can develop in both the 3/8" brass machined flare nut downstream of the furnace inlet, and in the 3/8" brass machined compression nut ahead of the main burner (Figure #1). Such a condition can, in the extreme, permit a combustible gas mixture to accumulate in the vehicle.

Suburban Manufacturing Company has initiated this recall campaign with respect to the furnaces and GMC Truck and Coach has provided them with the owner names and addresses of the vehicles involved. Fittings and related gas lines must be replaced on all affected vehicles.

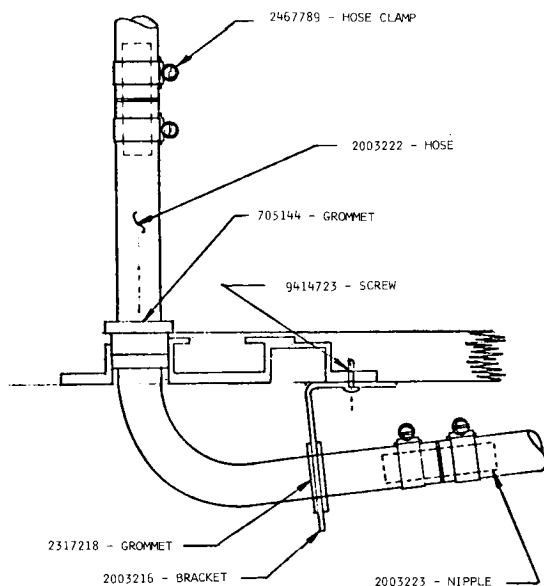
Figure #4

PREHEAT HOSE AND FLOOR BRACKET
INSTALLATION - 1973 & 1974 MODELS

3. Remove preheat elbow from floor sill.
4. Enlarge preheat elbow holes in floor sill to 1-1/4" using a hole saw.
5. Install hose bracket to floor sill by using bracket as a template to drill two 5/32" holes for 10-16 x 5/8 screws. (See Figure #4).

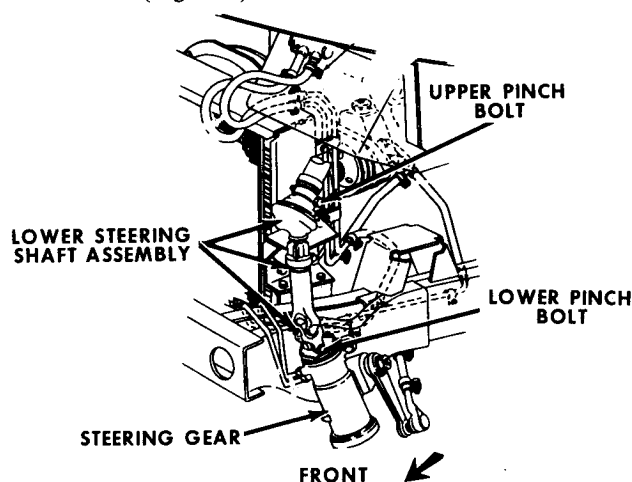
Figure No. 1

GMC Truck & Coach Division has determined that a defect which relates to motor vehicle safety exists in some 1976 MotorHomes and TransModes. The lower steering shaft assembly may have been assembled without a steering shaft companion flange nut and/or cotter pin. If the steering shaft is not properly secured, the steering shaft may become detached from the companion flange. If this happens, it would result in complete loss of steering control and, should the vehicle be in motion, a vehicle crash could occur without prior warning.

1. Raise left front access door.
2. Remove lower steering shaft upper pinch bolt and nut (Figure 1).

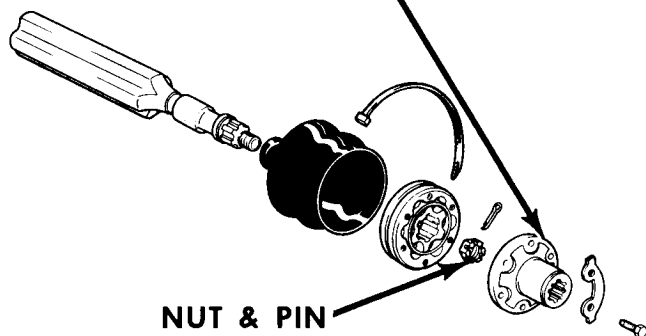
NUT & PIN

**INSERT FINGER
AND FEEL FOR NUT
AND COTTER PIN**

3. Separate lower steering shaft from upper shaft.
4. Insert finger into companion flange and feel for presence of slotted nut and cotter pin (Figure 2).
5. If nut and pin are present, reinstall lower shaft and torque upper pinch bolt nut 40–45 ft. lbs.
6. If nut and/or cotter pin is missing, install a new complete lower steering shaft assembly, torque upper pinch bolt nut 40–45 ft. lbs. and torque lower pinch bolt nut 35–45 ft. lbs.
