MOTORHOME SERVICE BULLETINS INDEX

TRUCK & COACH DIVISION
GENERAL MOTORS CORPORATION
Pontiac, Michigan 48053

**INDEX
OF
GMC MOTORHOME SERVICE BULLETINS**

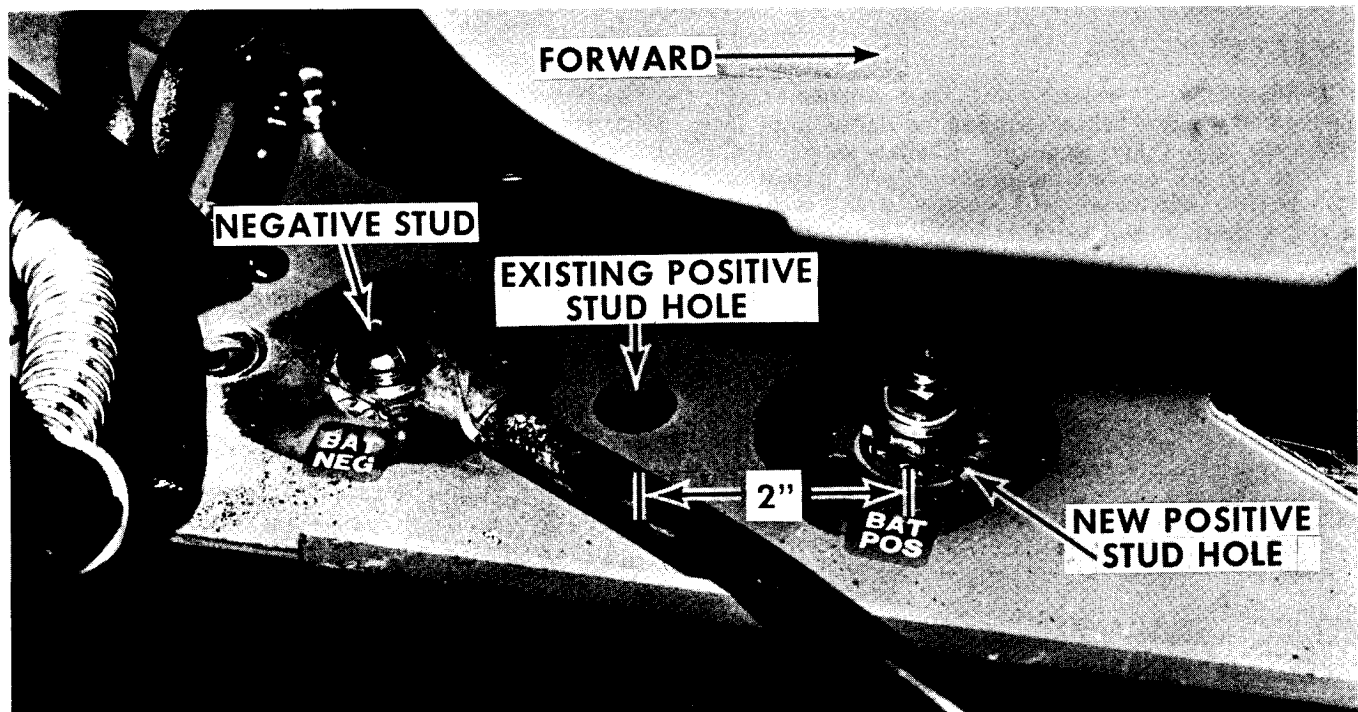
Figure 2

The 110 Volt AC conduit on these Onan generators may contact the positive battery terminal or starter solenoid post resulting in a short to ground of battery power. Also the 110 Volt AC conduit and cable insulation may wear through from contact with the negative battery terminal causing a short to ground of 110 Volt AC power. Such shorting will damage wiring and generator components and can result in a fire. A fire may result from shorting of the battery power to ground even if the Onan generator is not operating. The fire may burn the fuel supply hose to the generator unit resulting in a gasoline fed fire. Fires originating at the Onan generator could spread to the passenger compartment and cause burn injuries and asphyxiation of occupants.

8. Drill a 5/8" hole located two inches forward of existing hole as shown in Figure 2.
9. Install cable on stud making sure that the insulating washers are installed as shown in Figure 3.
