MOTORHOMES INTERNATIONAL NEWSLETTER

SUMMER 2014

ISSUE 128

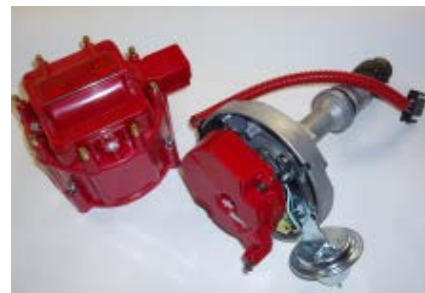
First, bump the motor over on the starter until the timing slot on the harmonic balancer (behind front lower pulley) lines up about with 0 (zero) on the timing tab, this will put the #1 cylinder on the TDC (top dead center). The piston will visit TDC twice on a 4 cycle motor – it can be on #1 or on #6 – to verify it is correct, follow the #1 plug wire back to the distributor cap and mark its post with masking tape. Set the cap back on the distributor and put a small piece of tape (marked as tape #2) on the distributor housing directly below your #1 plug wire terminal (post). Next, put a third tape tag (#3) on the block 'directly' in line below your #2 tape. Now tip the cap back and see if the rotor tip is pointing to the #1 post (which is marked with the #3 tape on the base).

If it is not, then that tells you the rotor is pointing at #6 and the motor has to be 'bumped' over one more time, slowly until the timing slot comes back in line with the timing tab.

Now, as you lift it 'straight up', the rotor will turn about 1". Note where the rotor tip is now pointing and place a piece of tape (#4) or use a marker pen to mark the distributor housing directly below the rotor tips new location.

This step works for you in reversing the sequence when you re-install the distributor. You will lower it down with the rotor pointing over tape #4. The housing gets lined up with tape #2 directly over tape #3. Lower in place, engaging the hex and the rotor will rotate back the 1" and the rotor tip will be over tape #2. Bingo! You are back where you started.

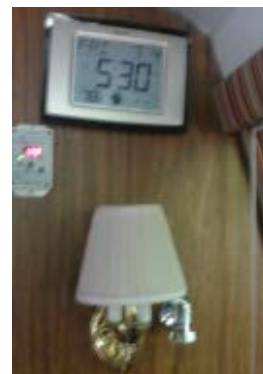
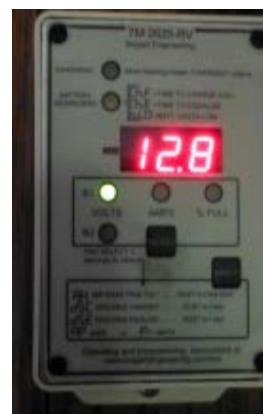
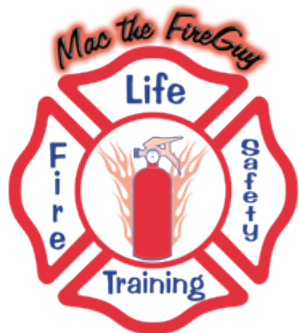
We installed a Bogart Engineering “TM-2025 Trimetric Battery System” – a device that keeps very accurate track of the house batteries and a basic track of the starting battery. As the manufacturer says, the unit is designed to monitor:

The unit is relatively small (4.5 x 4.75 x 0.9 deep) and is nice looking. Since our inverter and shore power connections are just below our fridge, we mounted it on the adjacent wall.
