## GMCMH Entry Door Latch Tutorial

This treatise is intended to share some of the knowledge I've gained about the GMC's entry door latch assembly. It includes instructions for unlatching the door when neither the outside nor the inside handle is effective.

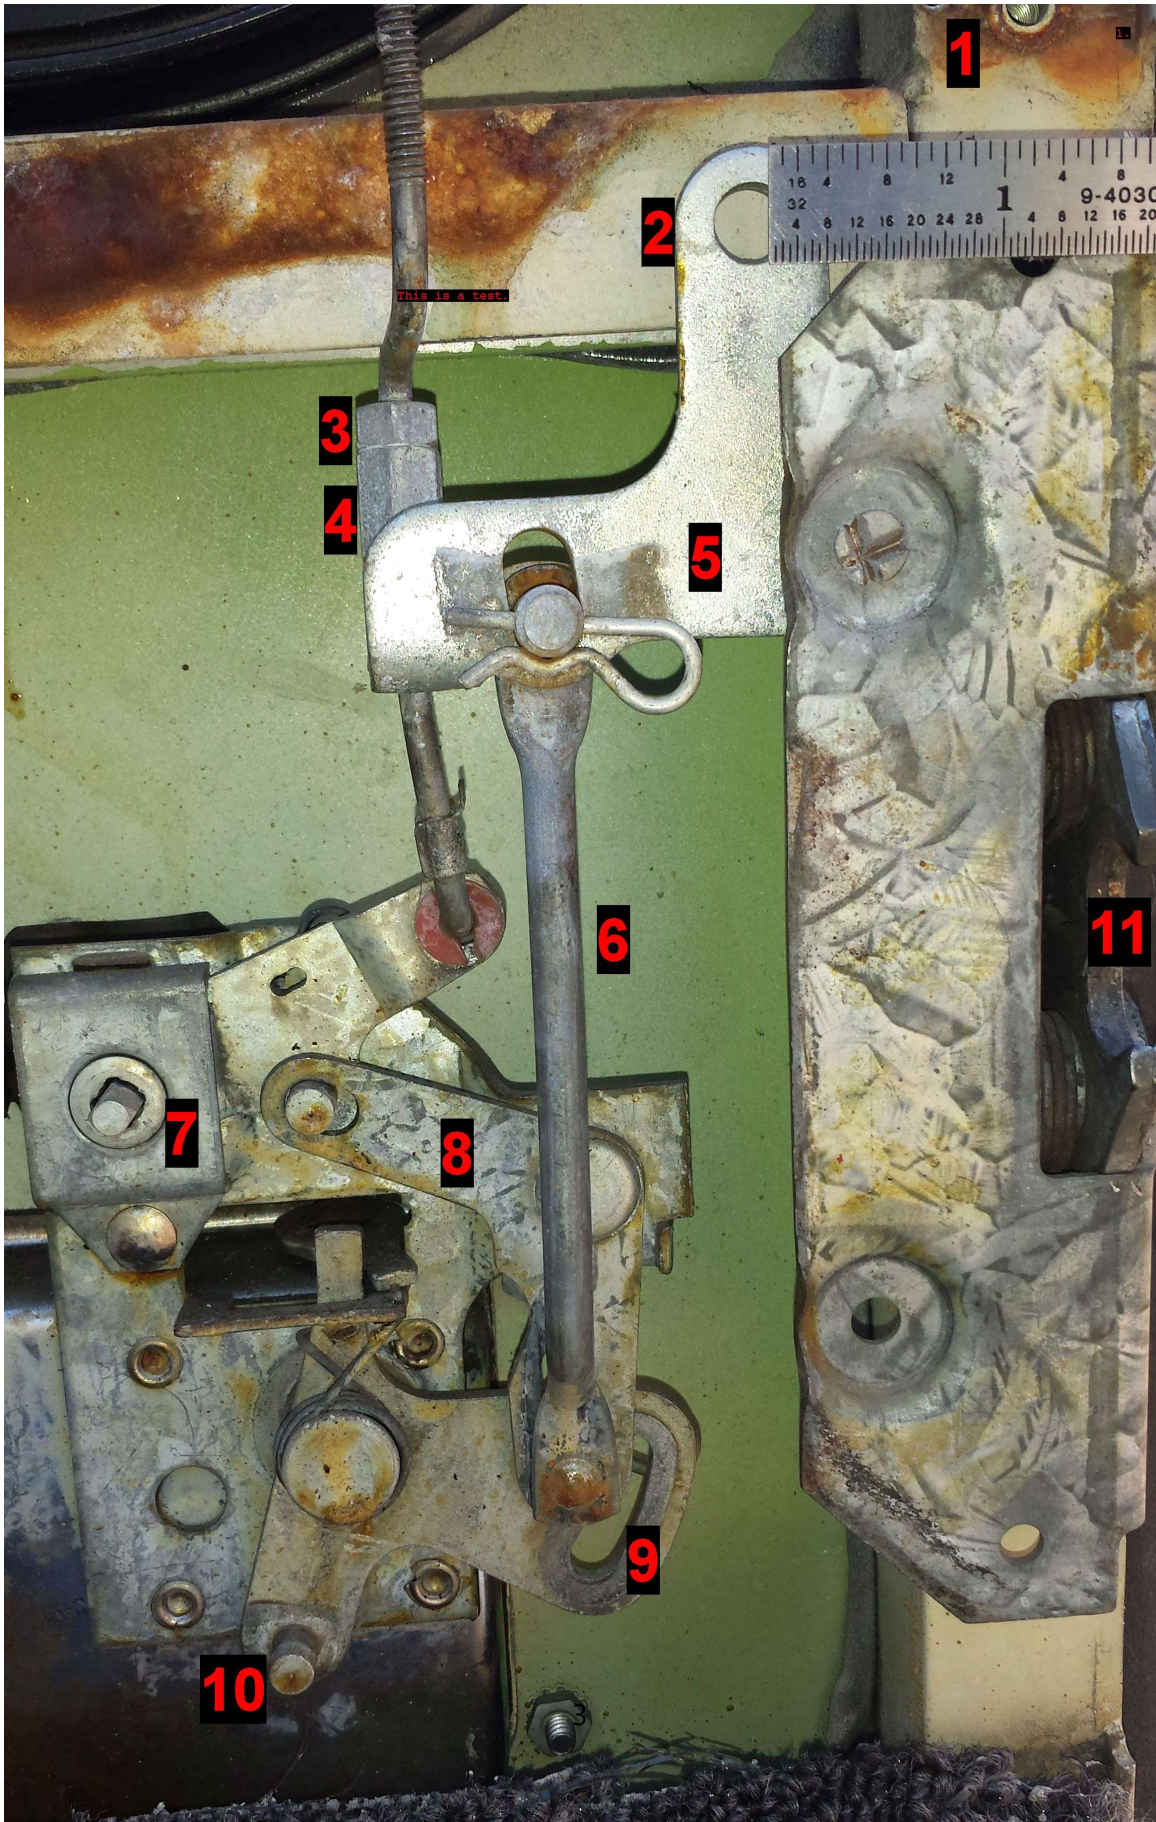
First, a general description of the latch's operation (all numbers refer to the red on black labels I've added):

At the right of the photo, at 11, is the actual latch, those being the two jaws which grip the striker when the door is closed and latched. Those jaws, and their operating mechanism are part of a discrete assembly, which is everything to the right of, and including, the arm labeled 5. The jaws, 11, operate simultaneously when depressed by the striker. They have two "latched" positions, "Intermediate" and "Closed". When in either of those positions, they cannot open unless arm 5 is rotated clockwise.

Arm 5 can be rotated by either the outside or the inside handle. Pulling the outside handle causes the arm with the labels 9 and 10 to rotate counterclockwise. If the latch is not locked, the 9/10 arm pushes up on connecting rod 6, which results in arm 5 rotating clockwise, releasing the latch jaws. Alternately, the inside handle can rotate the 9/10 arm via a connecting rod which fits on pin 10. (The inside handle being attached to the cover over all this stuff, it obviously can't be shown.)

Now to the locking mechanism: Notice the slot at 9 on the 9/10 arm. In this photo, the latch is unlocked -- the pin of link 6 is seated in a "notch" of the slot so that movement of arm 9/10 results in movement of link 6. In the locked position, arm 8 moves link 6's pin into the curved slot at 9 so that movement of arm 9/10 does not cause movement of link 6. The movement of arm 8 is caused by motion of the vertical link with the 3 & 4 labels -- the threads at the top of that link are for the "Lock Button".

I posted to GMCNet earlier about the lockout prevention feature that's available to us. Here's how it works: When the jaws 11 close, arm 5 momentarily rotates clockwise very slightly. It's not visible in this photo, but link 3/4 passes through a hole in an arm bent to the rear of arm 5. So, when arm 5 rotates, it raises link 3/4, causing arm 8 to rotate CCW, moving link 6's pin into the curved slot at 9 -- unlocking the latch. If the lockout prevention feature is to be implemented, the locknut at 3 must be loosened so that the barrel nut 4 can be adjusted pretty precisely -- if it's too low, the latch cannot be locked; too high and the door can be latched with the lock ON. Be sure to re-tighten the locknut 3.

Now, a fix, in case you disregard the previous paragraph: Notice the machinist's scale at the upper right of the photo: Just above it, at 1, is a nutsert for one of the 5 exposed screws holding the metal trim panel. That is an always-visible reference point which one could use as a guide for emergency opening of the latch. Notice hole 2 in arm 5. It's not used for anything. So, if one drilled a hole through the metal trim panel directly over (or slightly to the right of) hole 2, it would be possible to rotate arm 5 CW, unlatching the door! The best I could measure, a 1/8" (or larger) hole 7/8" below the nutsert at 1 and 1-1/8" to its left, would suffice. A nail, punch, screwdriver, etc., could be inserted to pry the lever to the right. It might even be a good idea to use a 3/4"-1" hole saw at that position to create an emergency access which could be unobtrusively concealed with a hole cover. At any rate, there's really no need for a large hole to be cut to unlatch the door -- if moving arm 5 won't do it, you've got a BIG problem.

If you ever see this scene, I strongly suggest that you remove the entire assembly, clean all the old grease out, and re-grease and oil the mechanism. My door, which always latched nicely, after that treatment now latches superbly!
